**COMMUNITY OF VICTORIA,  
PRINCE EDWARD ISLAND  
SEAWALL REPLACEMENT PROJECT**

HABITAT ASSESSMENT & GEOTECHNICAL INVESTIGATION

20 September 2017

Project No: 17-12374

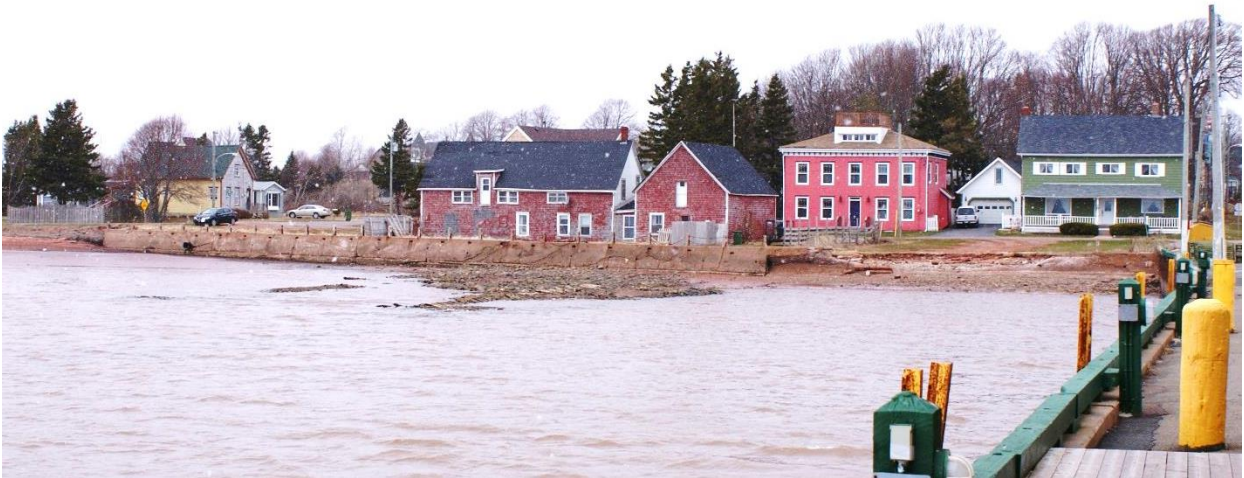
The Community of Victoria in Prince Edward Island has identified replacing the current deteriorating seawall (Figure 1) on the waterfront as a community priority. It has been proposed that the existing concrete seawall will be replaced with a rubble mound seawall, which is expected to provide better protection against erosion and wave action; thus, protecting property and important infrastructure within the community for many years to come. While continuing to offer an aesthetically pleasing look along the popular waterfront, the Project is proposed to incorporate a pedestrian walkway as shown in Figure 2.

Figure 1. View of the current deteriorating concrete seawall on the Community of Victoria, PE waterfront as viewed from the wharf in April 2017.

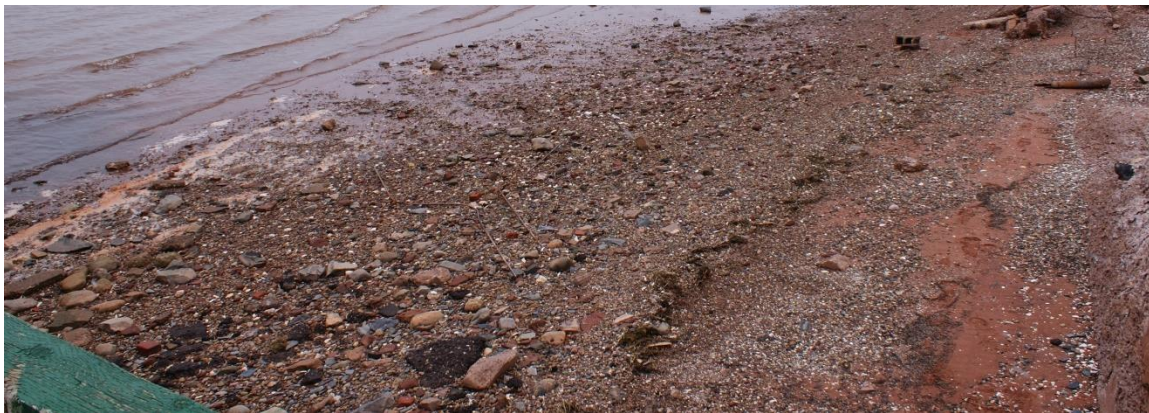
The course sand and gravel section was a small habitat which is located directly adjacent to the wharf (Figure 4). While this habitat likely started off as a course sand beach, it is now covered with gravel, rocks, broken pieces of seawall and broken pieces of asphalt (Figure 9).

Figure 9. A view of the course sand and gravel habitat observed at the Community of Victoria waterfront in April 2017.

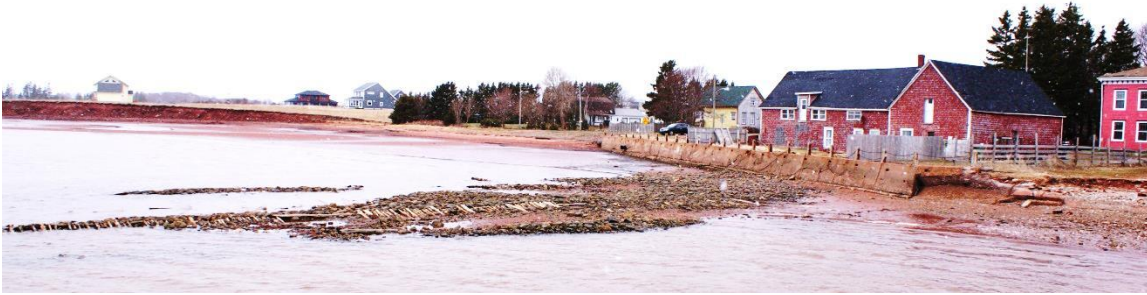
Figure 10. A view of the cobble and wood habitat, presumably a manmade former wharf or breakwater based upon a review of historical aerial photographs, from the wharf at the Community of Victoria waterfront in April 2017.

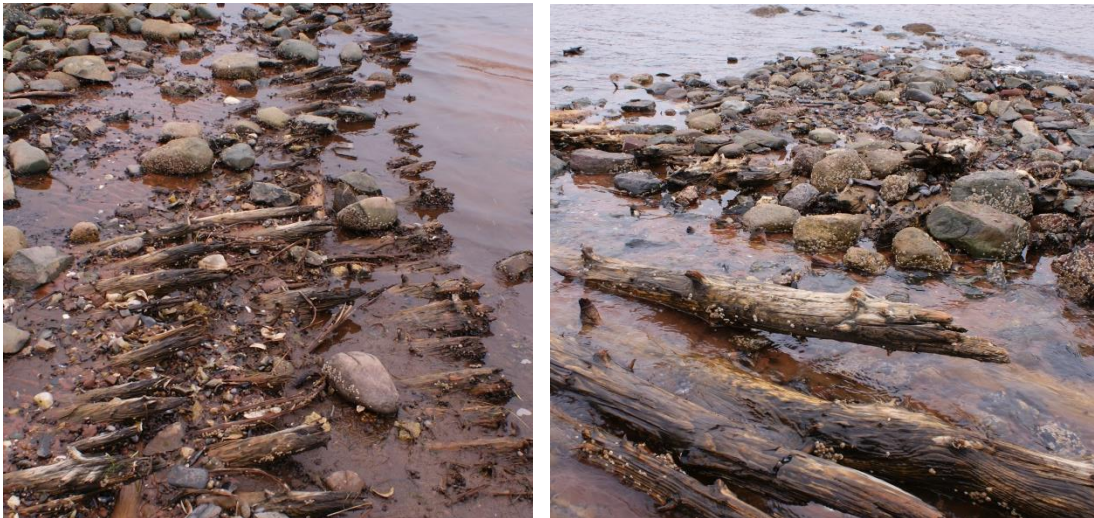
Figure 11. A close-up view of the cobble and wood habitat, presumably a manmade former wharf or breakwater based upon a review of historical aerial photographs.

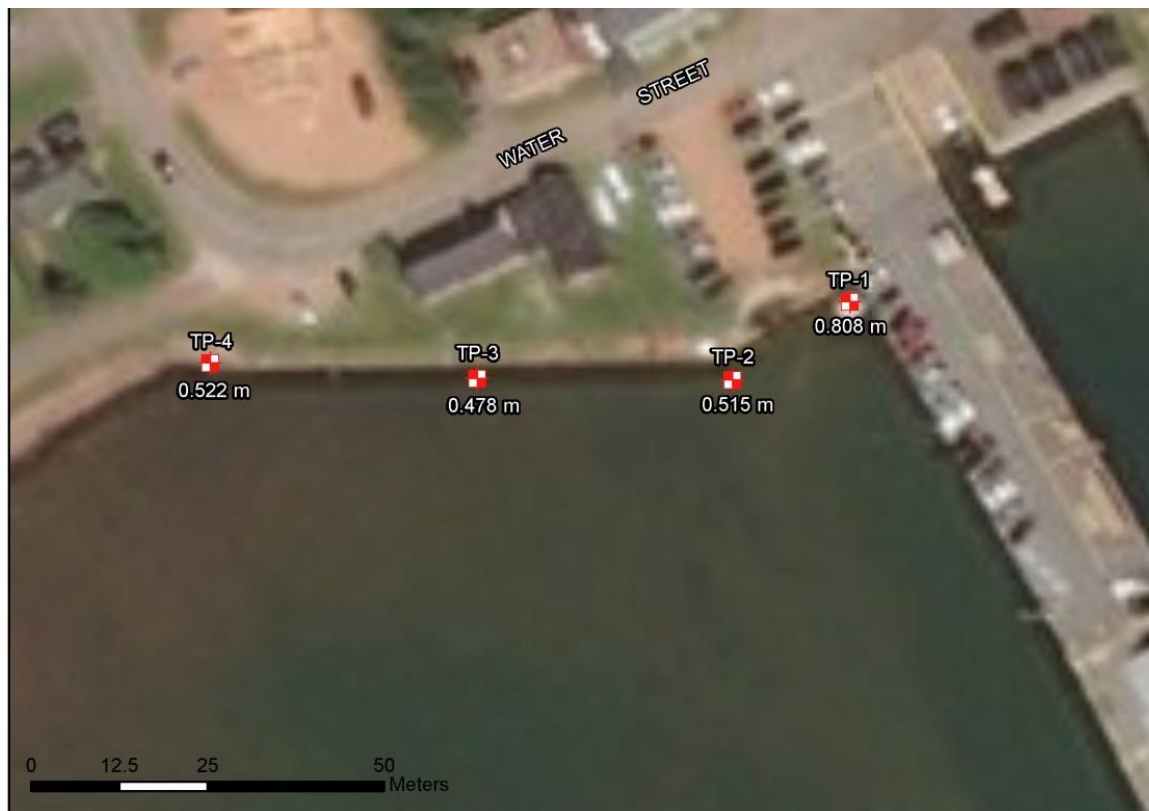
On August 30th, 2017, four (4) test pits were completed using a track mounted excavator provided by Curran & Briggs Limited under the direction of Alex Moulard, *P.Eng., PMP*, of Fundy Engineering. The test pit locations were distributed evenly along the seaward side of the seawall such that an overall understanding of the subgrade could be attained (Figure 18).

Figure 18 – The location of the four test pits, and the height above Mean Low Water of each, at the Community of Victoria Seawall site.

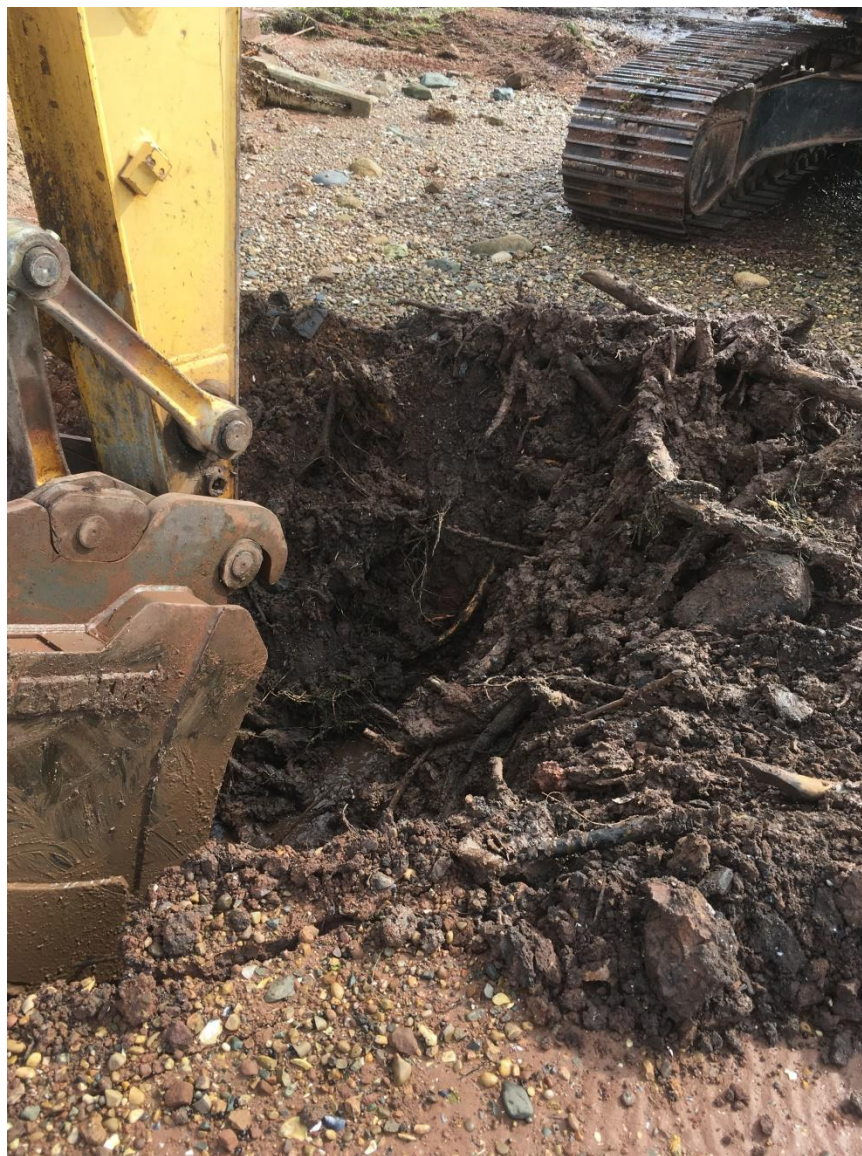
Soils encountered in this geotechnical investigation can generally be described as **Loose Red SAND and GRAVEL with Cobbles** over **Loose Black Silty SAND with Wood Debris** over **Compact Red COBBLES and BOULDERS** with some **Sand** over **Red Sandstone BEDROCK** (Figure 19, Figure 20).

Figure 19 - Wood Debris from Old Wharf encountered in a test pit at the Community of Victoria proposed seawall site.

Based on the observations made during the geotechnical investigation and our understanding of the proposed seawall project, at a minimum, the removal of the **Loose Red SAND and GRAVEL with Cobbles** and **Loose Black Silty SAND with Wood Debris** will be required. Any materials which are suspected to have been part of a previous wharf structure should be removed.

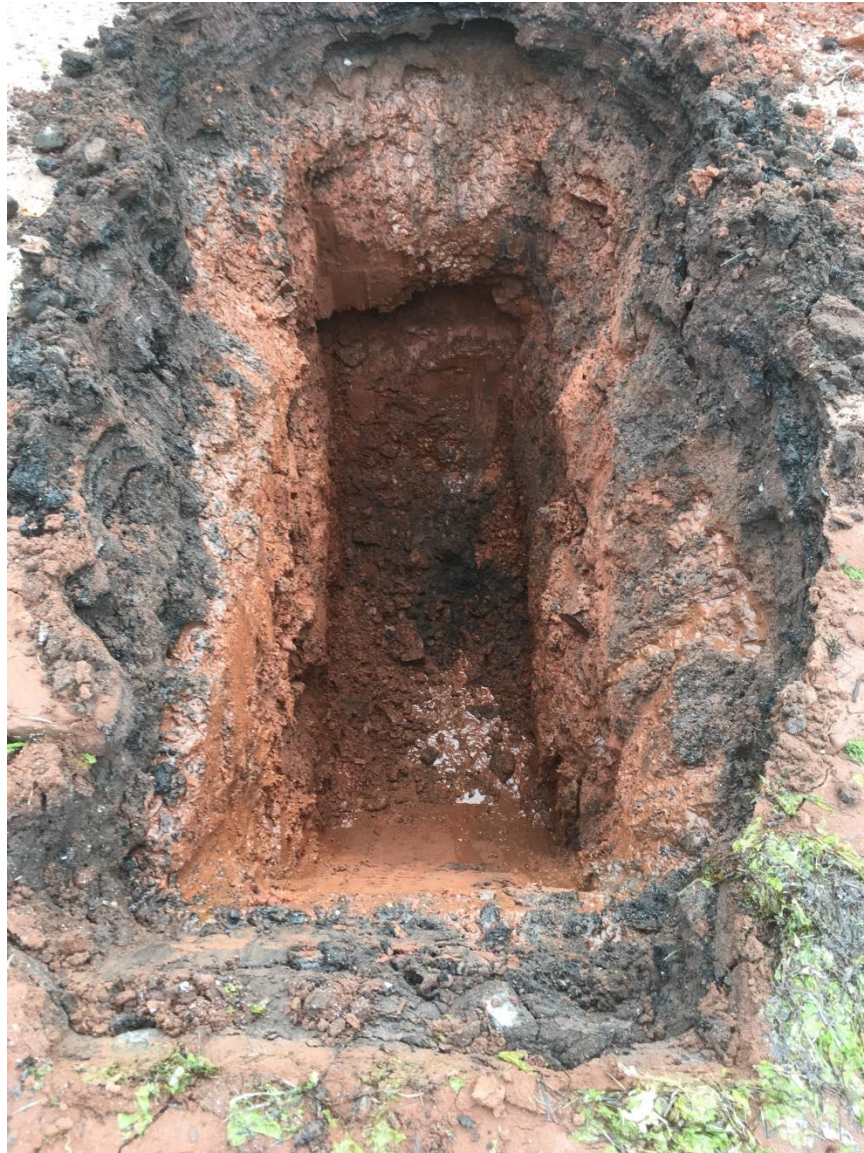
Figure 20 - Typical soils encountered at the Community of Victoria proposed seawall site.

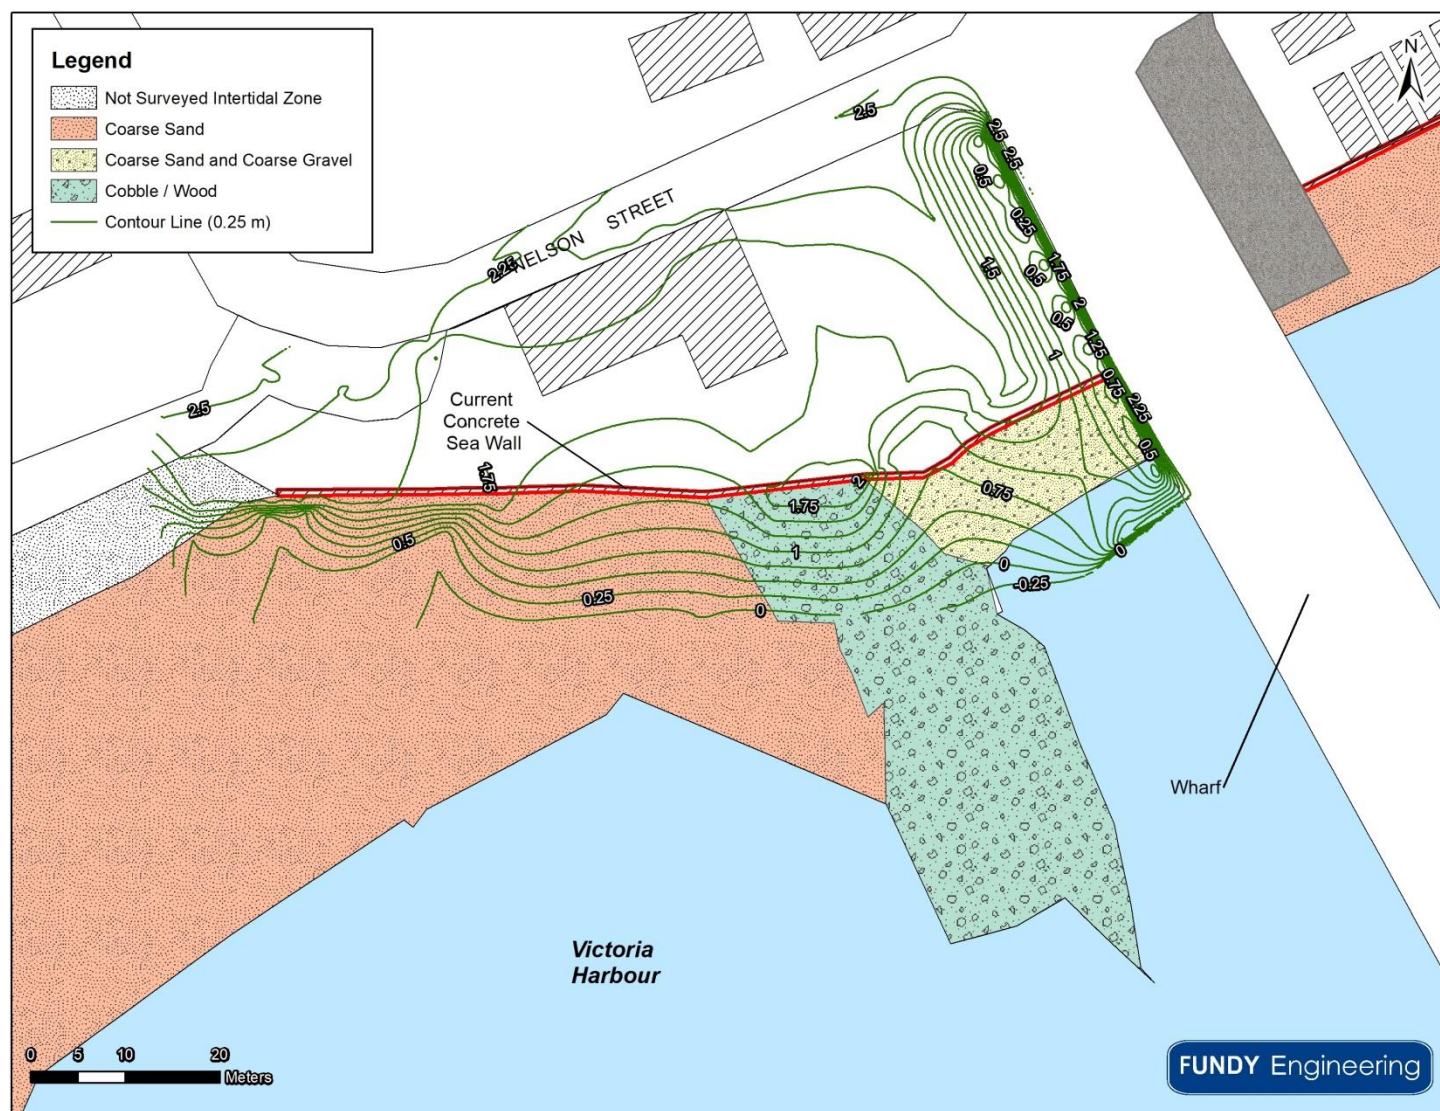
Figure 23 – Topographic survey results for the Community of Victoria Seawall Site. Existing deteriorating seawall is indicated in red.
