HAZARDOUS MATERIALS ASSESSMENT

Coast Guard Building

1 Queen Street,

ALL-TECH Project No.: PE22400

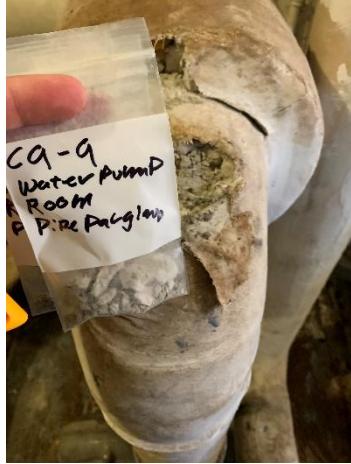
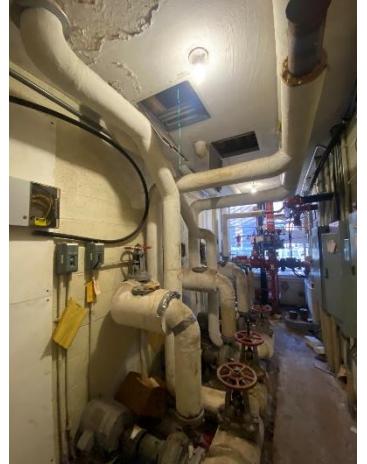
Pipe parging cement is present on pipe fittings as identified through various samples within the building. A total of six (6) parging cement samples were collected and none were found to contain asbestos.

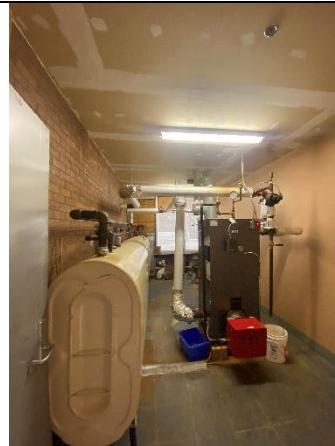
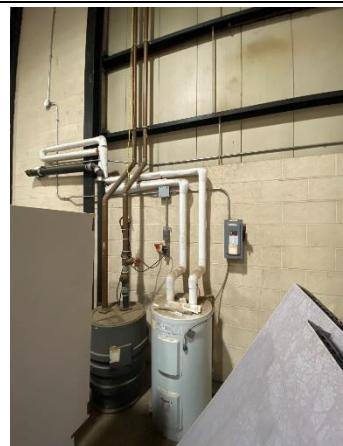
Newer boiler system in place.
Mechanical equipment is either uninsulated or insulated with non-asbestos fiberglass.

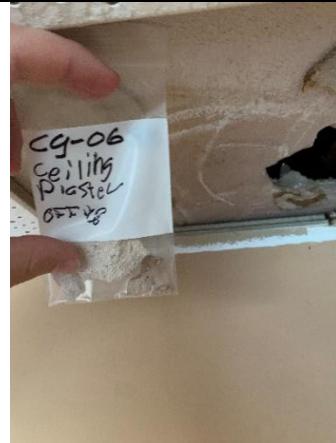
Plaster ceiling was noted and sampled in one office of the building.
The plaster sample was collected with both the white scratch coat and underlying base coats analyzed. None of the samples were found to contain asbestos.

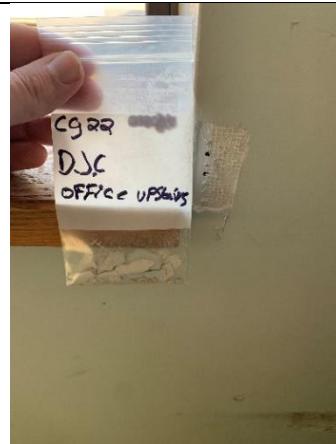
Drywall joint compound walls and ceilings were noted and sampled in various random locations throughout the building.
Representative sampling was completed within the building.
A total of ten (10) joint compound samples were collected during the assessment. None of the samples were found to contain asbestos.

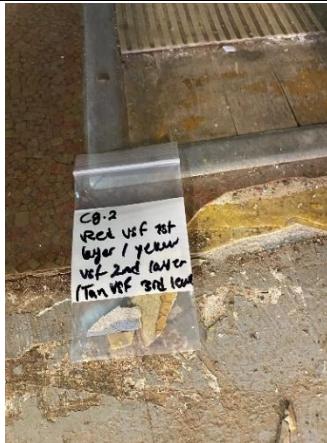
Sample No.:	Flooring Description	Location	Asbestos Type / Content (%)	Photo
CG-02	Red colour vinyl sheet flooring	Entrance to loading dock	40% Chrysotile

Room No.	Description	Sample No.	Material description	Asbestos Type & Content (%)	Estimated Volume or Area	Friable (F) Non-friable (NF)	Access	Condition	Action Code (refer to legend)	Photo
NA	Main level entry	CG-02	Red vinyl sheet flooring	Chrysotile 40%	1.86 m ²	F	A	Fair	3

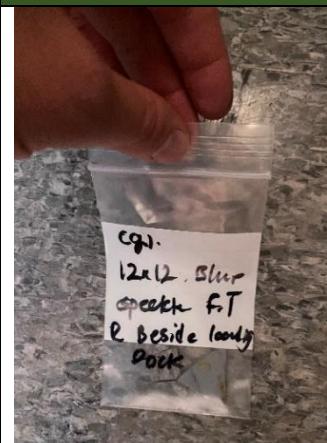
Sample No.:	Flooring Description	Location	Asbestos Type / Content (%)	Photo
CG-01 CG-12 CG-28	12" x 12" blue speckled floor tile with yellow mastic	Various locations	None Detected in floor tile or yellow or black mastic

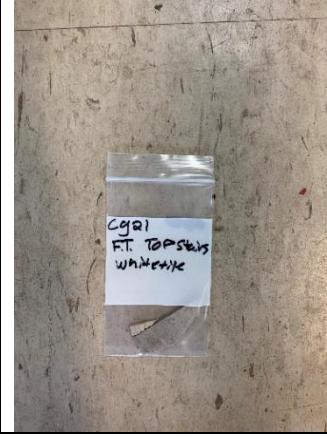
CG-21 CG-24	12" x 12" White floor tile with Yellow/black mastic	Top of Stairs Landing / Office	None Detected in floor tile or mastic

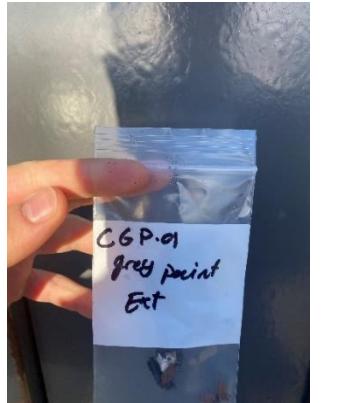
Sample No.:	Colour / Substrate Description	Location	Lead Content (%)	Photo
CGP-01	Gray siding paint	Exterior	0.96

Dispose of painted materials exceeding the criteria for leachable lead as hazardous waste.

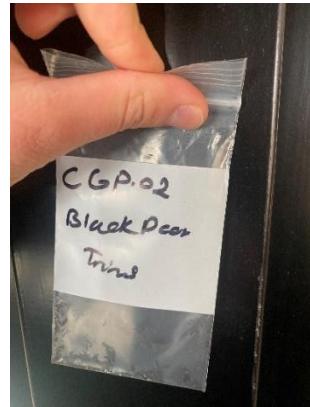
CGP-02	Black door trim paint	Warehouse Storage	0.25

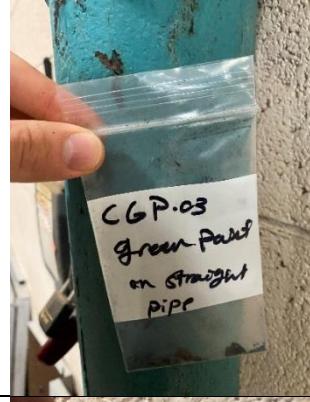
CGP-03	Green paint on pipe	Warehouse Storage	0.94

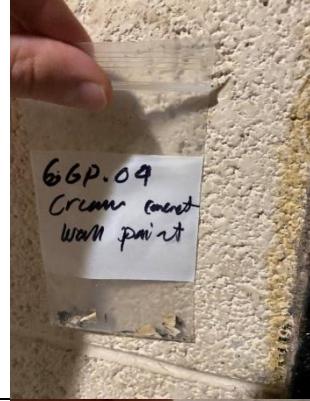
CGP-04	Cream wall paint on concrete block	Warehouse Storage	0.12

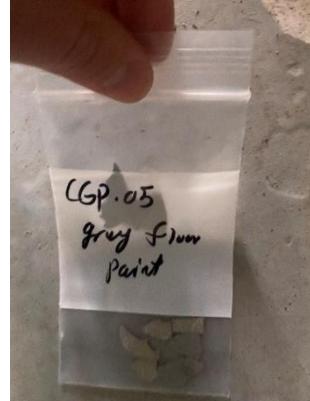
CGP-05	Grey floor paint	Warehouse Storage	0.15

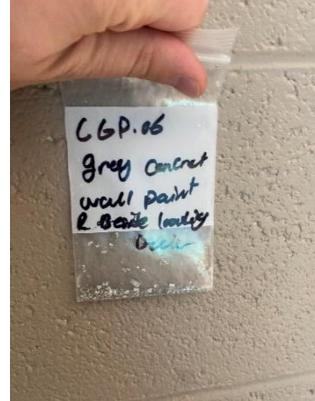
CGP-06	Grey wall paint	Warehouse office	< 0.0087

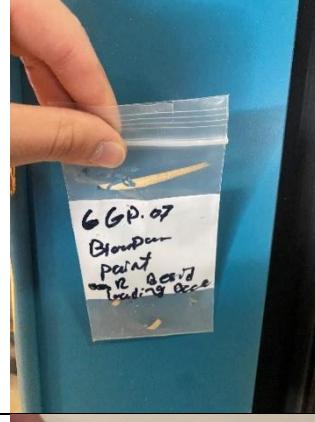
CGP-07	Blue door paint	Loading Dock	< 0.0087

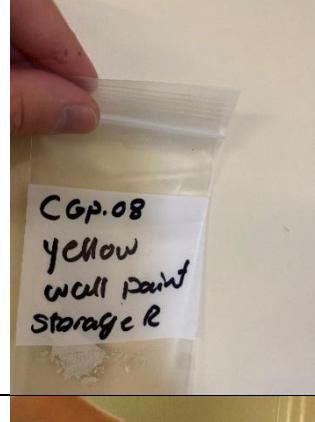
CGP-08	Yellow wall paint	Storage Room	< 0.0074

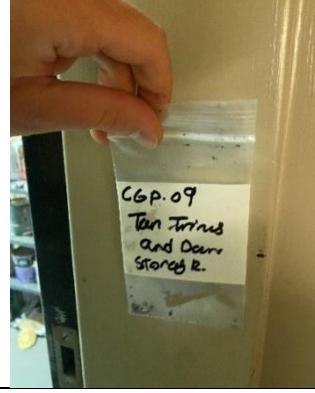
CGP-09	Tan paint / Trim & Doors	Storage Room	0.070

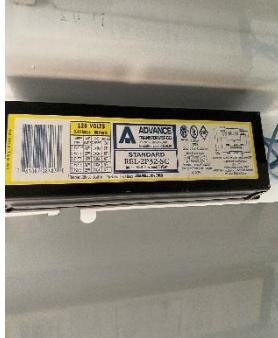
<p>Photo 1</p>

<p>Photo 1 - Advance Standard REL Lamp Ballasts with manufacturers label as "No PCB's".</p> <p>Photo 2 – Typical light fixtures for these ballasts.</p>

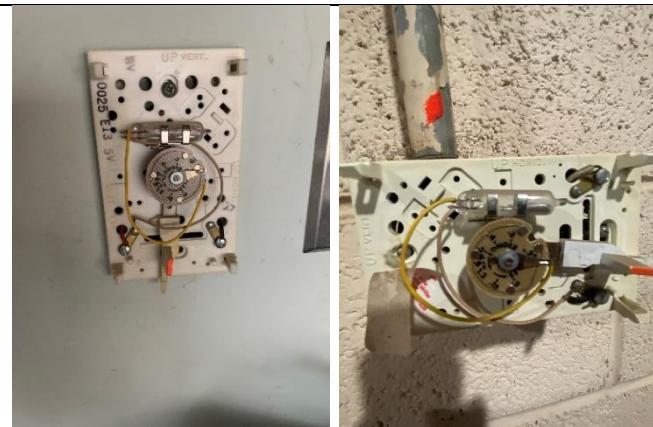
Mercury containing thermostats were observed within the building.

Do not break lamps or separate liquid mercury from components. Recycle and reclaim mercury from fluorescent lamps and thermostats when taken out of service. Mercury is classified as a hazardous waste and must be disposed of in accordance with applicable regulations.
