HAZARDOUS MATERIALS ASSESSMENT

Provincial Correctional Centre

275 Sleepy Hollow Road, Charlottetown, PE

May 12, 2023

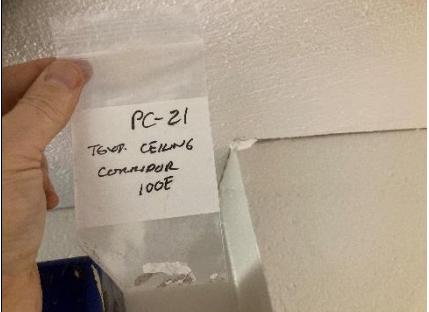
<p>Texture coat finishes were observed and sampled in three various locations within the building. None of the sampled were found to be asbestos containing.</p>

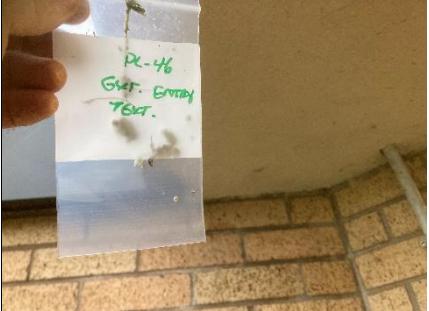
<p>Texture coat finishes were observed and sampled in two locations on the exterior of the building. None of the sampled were found to be asbestos containing.</p>

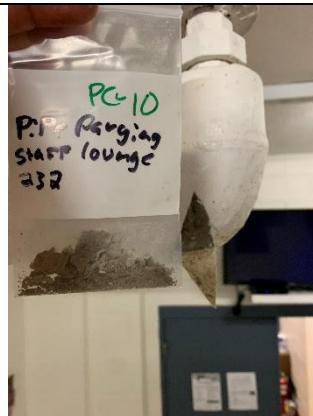
Photo 1

ACM parging cement is present on pipe fittings as identified through various samples within the building. A total of seven (7) parging cement samples were collected. Two of the samples were found to contain **1.5 – 5.7% Chrysotile Asbestos**.

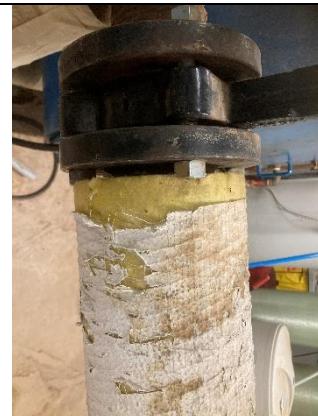
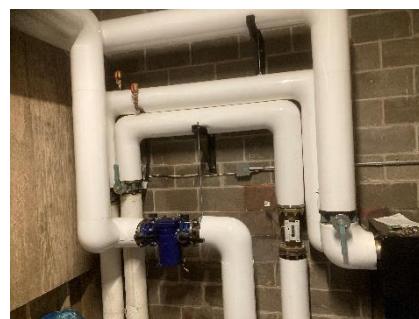
Straight sections of pipe are insulated with fibreglass insulation as identified through visual observations (see Photos 2 & 3).

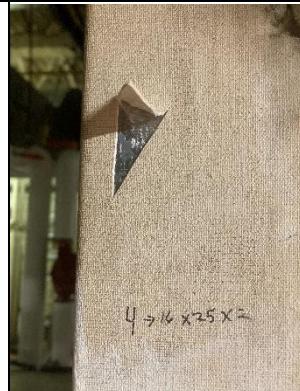
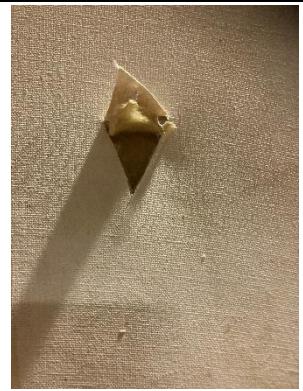
Penthouse mechanical room observed with either non-insulated or fiberglass insulation with canvas covering with no parging observed under wrap. No suspect asbestos coverings were noted or reported.

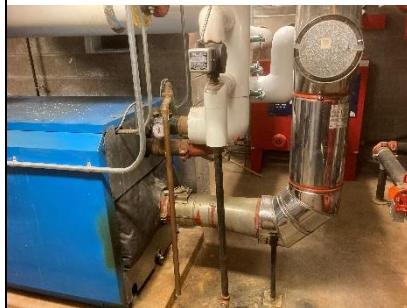
Modern mechanical equipment in exterior mechanical room 174 (photo 1). No insulated covering on boiler system.

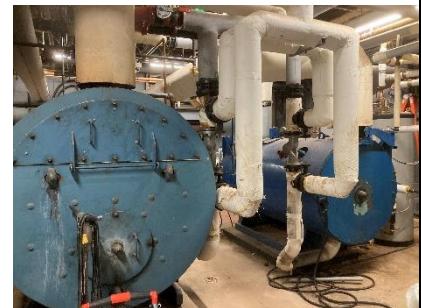
Mechanical equipment in boiler room 231 (photo 2). No insulated covering on boiler system.

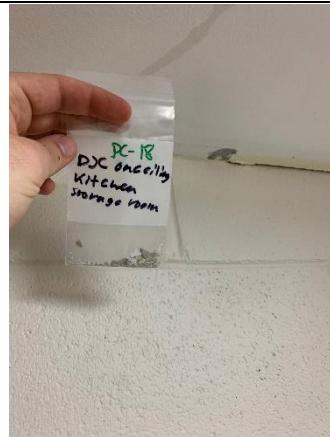
A total of five (5) joint compound samples were collected during the assessment. None of the samples were found to contain asbestos.

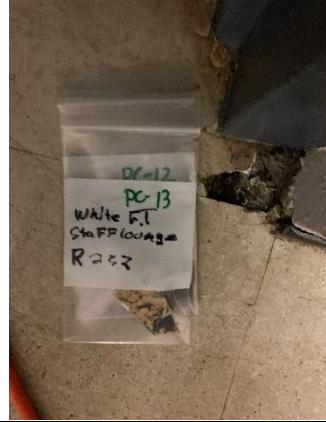
PC-13; PC-17; PC-19	12" x 12" white floor tile with black mastic	Room 232 Staff lounge	None Detected in floor tile or mastic

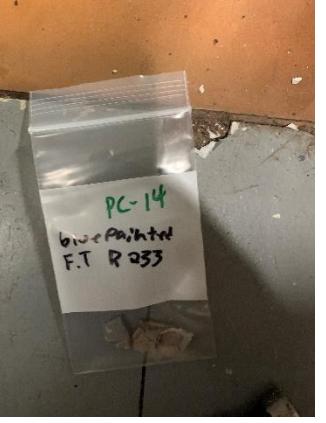
PC-14	12" x 12" white / blue paint	Room 233	None Detected

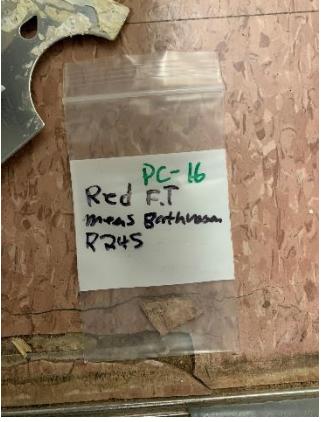
PC-16	12" x 12" red floor tile with yellow mastic	Room 245	None Detected in floor tile or mastic

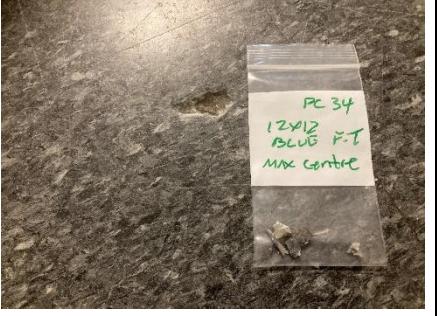
PC-34; PC-20; PC-35	12" x 12" blue floor tile with black mastic and levelling compound	Room 172	None Detected in floor tile, mastic or levelling compound

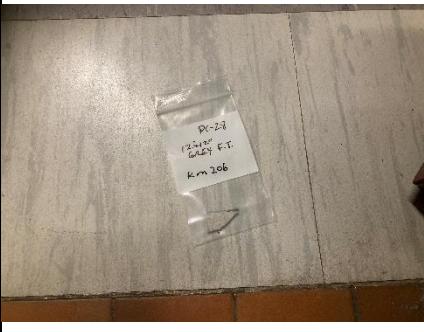
PC-28; PC-30	12" x 12" grey floor tile with black mastic	Room 206	None Detected in floor tile or mastic

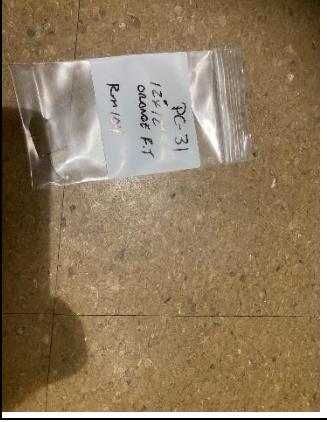
PC-31	12" x 12" orange floor tile with yellow mastic	Room 104	None Detected in floor tile or mastic

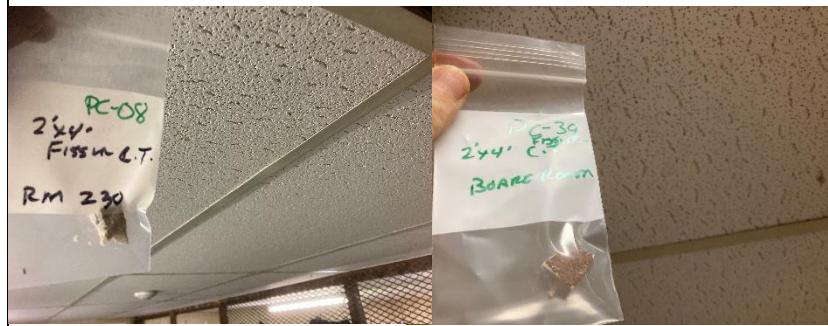
In-lay acoustic ceiling tiles were observed and sampled in various random locations throughout the building. The ceiling tiles were observed as fissure designs throughout. A total of five (5) ceiling tile samples were collected during the assessment. None of the samples were found to contain asbestos.

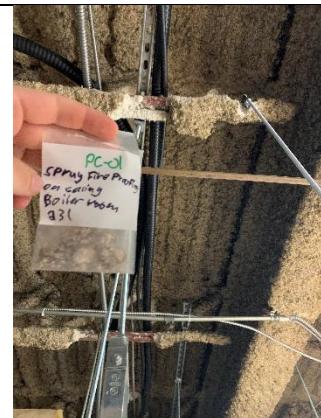
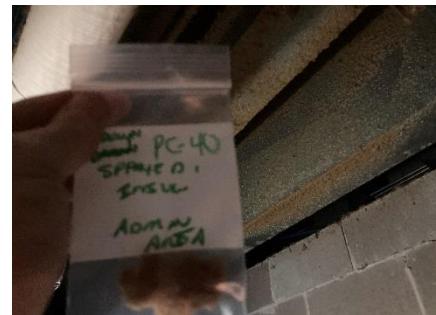
Sprayed fireproofing material samples were collected in the boiler room and admin room. Samples were analyzed as non-asbestos containing materials.

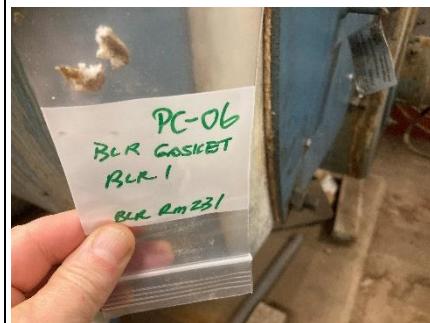
Boiler gaskets were sampled and analyzed as non-asbestos containing materials.

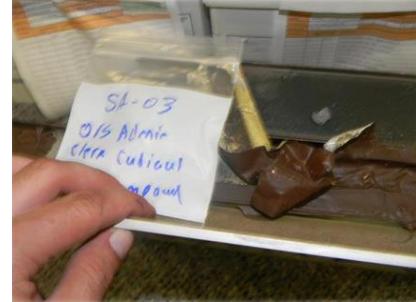
Brown duct mastic previously identified as containing 1.8 – 2.6% chrysotile asbestos (PLM report 09-25-2017).

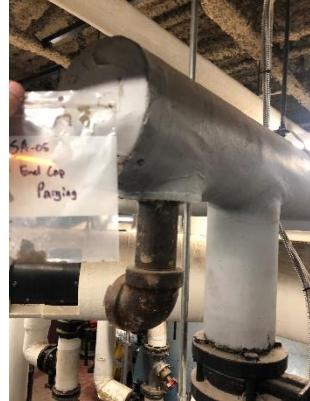
<p>Parging on grey boiler breeching end caps previously identified as containing 50% chrysotile asbestos (PLM report 02-26-2021).</p>

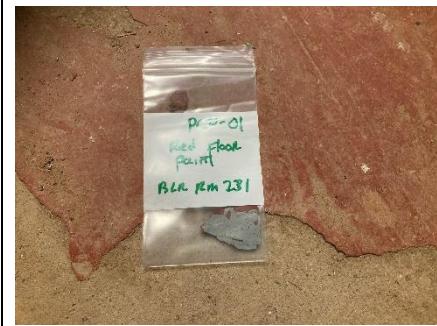
Sample No.:	Colour / Substrate Description	Location	Lead Content (%)	Photo
PCP-01	Red paint / Concrete floor	Boiler Room 231	0.0071

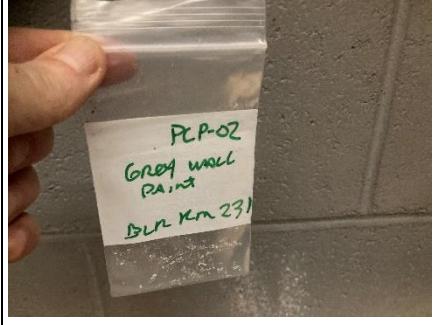
PCP-02	Grey paint / Concrete wall	Boiler Room 231	0.031

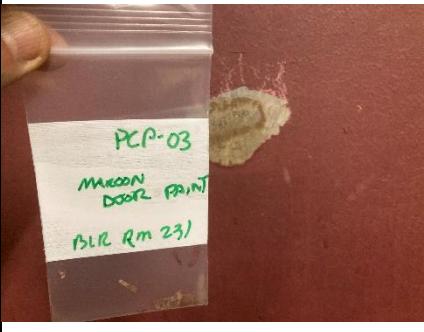
PCP-03	Maroon paint / Metal door	Boiler Room 231	1.6

Dispose of painted materials exceeding the criteria for leachable lead as hazardous waste.

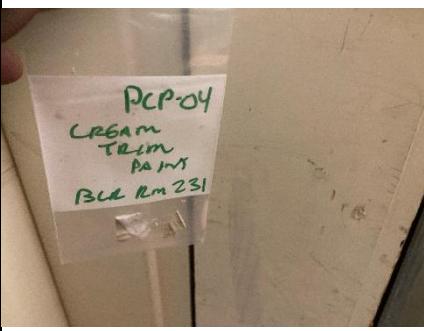
PCP-04	Cream paint / Trim	Boiler Room 231	< 0.014

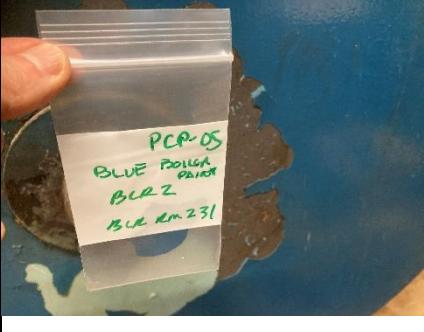
PCP-05	Blue paint / Boiler surface	Boiler Room 231	0.25

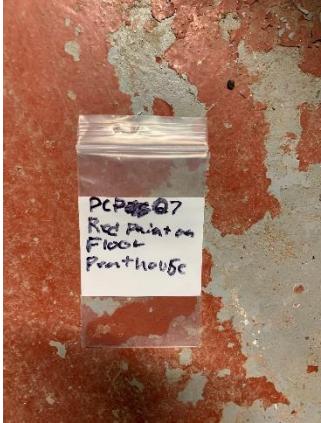
PCP-07	Red paint / Concrete floor	Penthouse	0.016

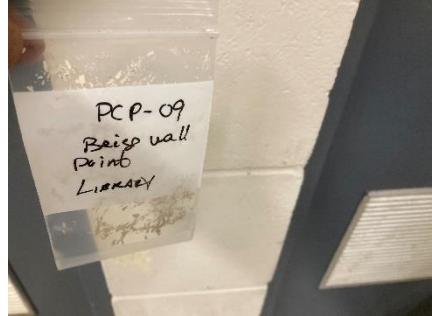
PCP-09	Beige paint / Concrete wall	Library	0.0075

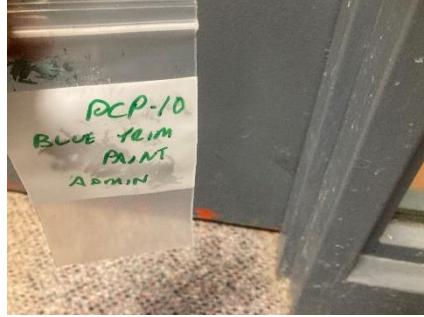
PCP-10	Blue paint / Trim	Admin	< 0.01

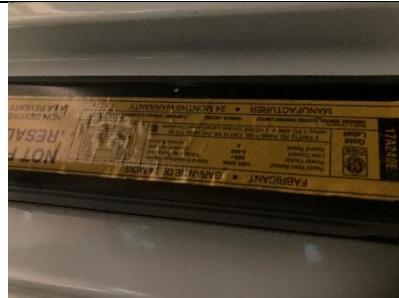
Photo 1 – GE Gold Label lamp ballasts with serial number 17A240E. Through referencing the ballasts are non PCB containing.

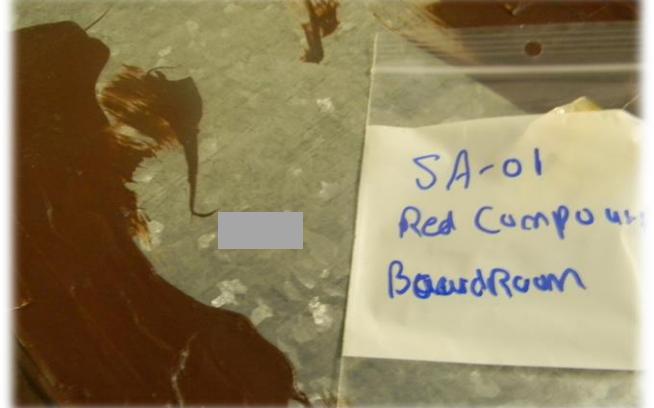
Sample ID	Material Description / Location	Asbestos Content (%)	Asbestos Content (%) Additional Layers	Photo
SA-01	Red compound mastic / Boardroom	2.1% Chrysotile	NA

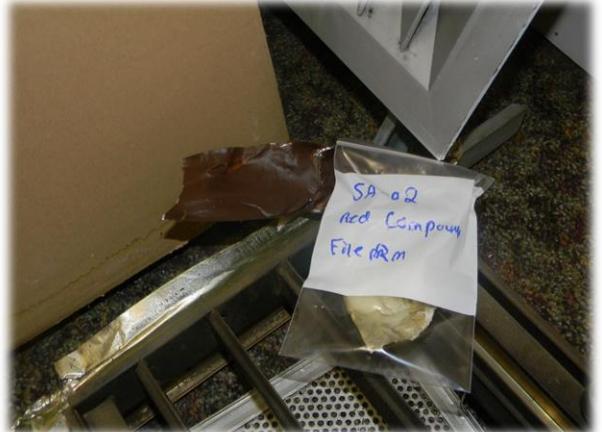
Sample ID	Material Description / Location	Asbestos Content (%)	Asbestos Content (%) Additional Layers	Photo
SA-02	Red compound mastic / File Room	2.4% Chrysotile	NA

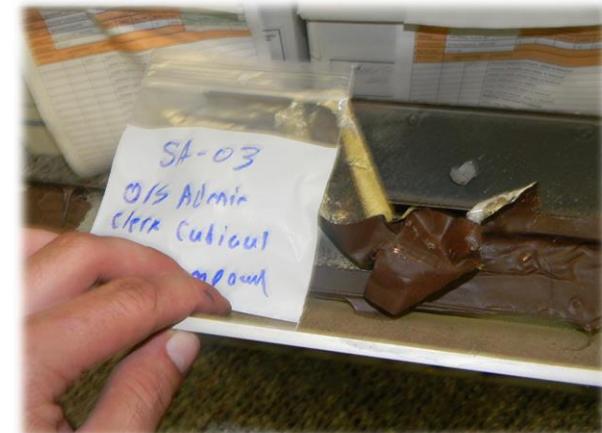
SA-03	Red compound mastic / outside admin clerk cubicle	1.8% Chrysotile	NA

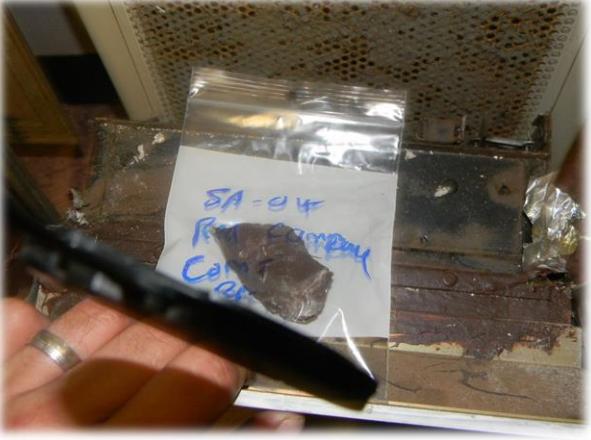
Sample ID	Material Description / Location	Asbestos Content (%)	Asbestos Content (%) Additional Layers	Photo
SA-04	Red compound mastic / Com 5 Room	2.6% Chrysotile	NA
