HAZARDOUS MATERIALS ASSESSMENT

Royalty Centre
40 Enman Crescent,
Charlottetown, PE

June 28, 2023

ALL-TECH Project No.: PE22400

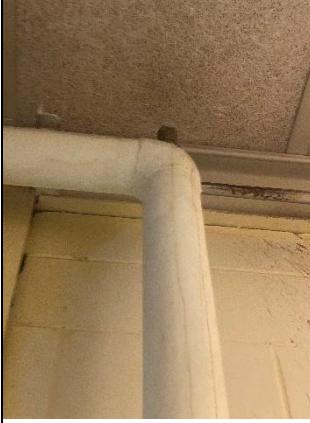
Photo 1

ACM parging cement is present on pipe fittings as identified through various samples within the building. A total of twenty-three (23) parging cement samples were collected and 21 of them were found to contain 20% - 65% Chrysotile Asbestos .

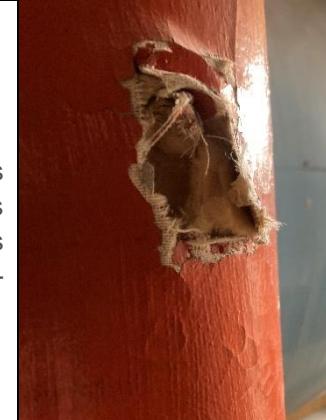
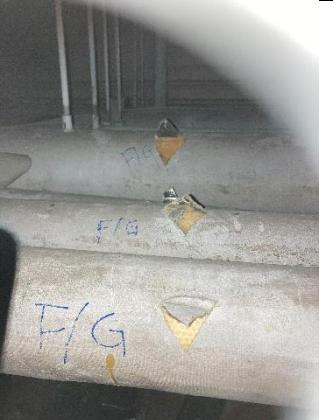
<p>ACM parging cement is present on hangers and fittings as identified through various samples as visual observations which would be considered fair / poor condition.</p>

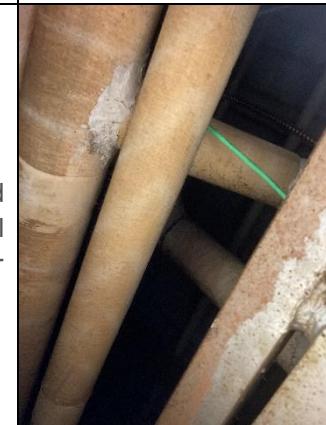
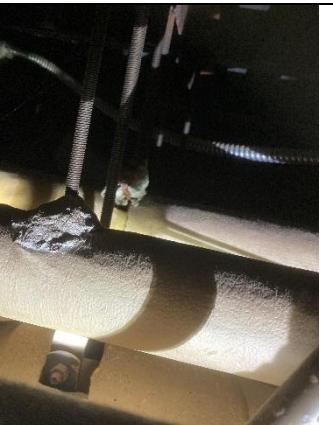
<p>ACM parging cement is present on pipe fittings in boiler room. Sample RC-33 above boiler found to contain 60% Chrysotile Asbestos.</p>

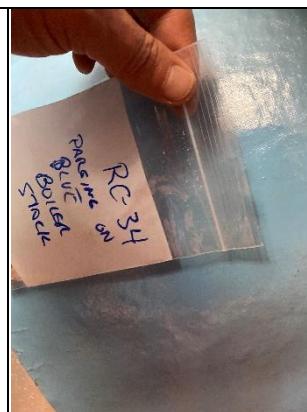
Photo 1

ACM parging cement was sampled on mechanical boiler stack insulation in the Boiler Room and found to contain **60% Chrysotile asbestos** (photo 1).
Boiler gasket was sampled and was found to contain **50% Chrysotile asbestos** (photo 2).

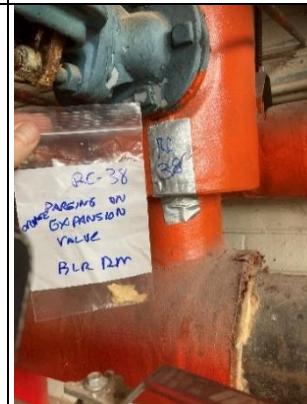
Photo 3

ACM parging cement was sampled on mechanical expansion valve insulation in the Boiler Room and found to contain **25% Chrysotile asbestos** (photo 3).

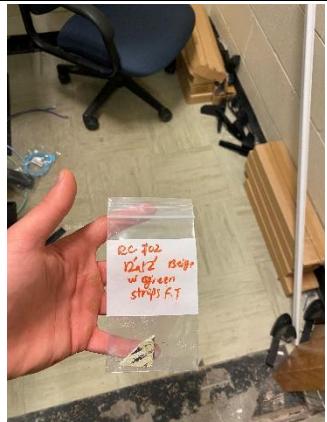
RC-102	12" x 12" Off-white floor tile with black mastic	Behind electrical room	<p>Floor tile: 1.1% Chrysotile Asbestos</p> <p>None Detected mastic</p>

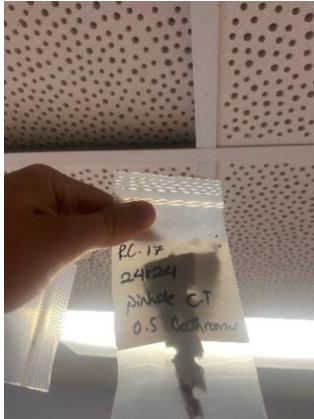
Photo 1

Various ceiling tile compositions were noted and sampled. Ceiling tiles were observed as pinhole (photo 1), dotted (photo 2), fissure dotted (photo 3), and fissure (photo 4).

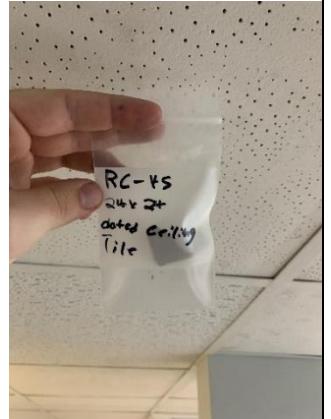
Photo 2

A total of thirty-seven (37) ceiling tile samples were collected during the assessment. Four (4) of samples analyzed were found to be asbestos containing (samples RC-16, RC-45, RC-89, RC-96). All samples reported as ACM ceiling tiles noted as fissure dotted tiles as noted in photo 3 with the exception of one sample(RC-45) identified as dotted ceiling tile (photo 2).

The one dotted ceiling tile reported was found to contain **1.1% Amosite asbestos**.

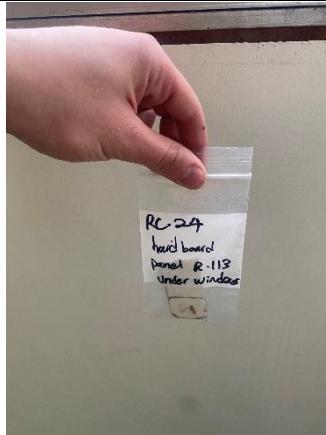
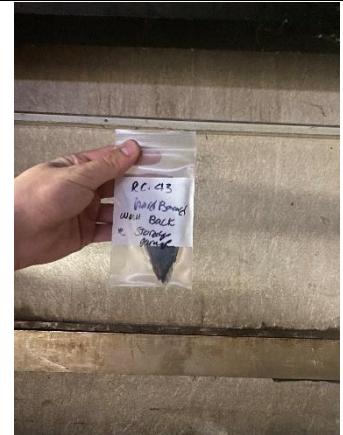
A total of nine (9) hardboard samples were collected during the assessment. All of them were found to contain **15%-25% Chrysotile Asbestos**.

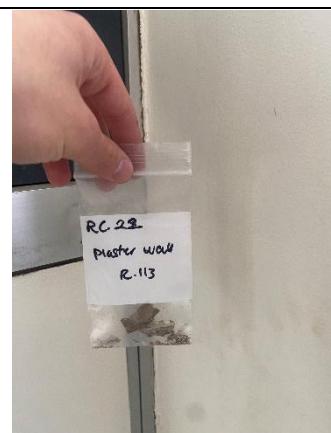
A grey wall adhesive layer was analyzed on sample RC-22 and was reported to contain **2.3% Chrysotile Asbestos**.

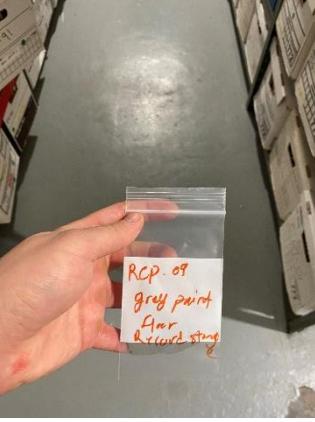
RCP-09	Grey paint / Floor surface	1 st Level record storage	0.13

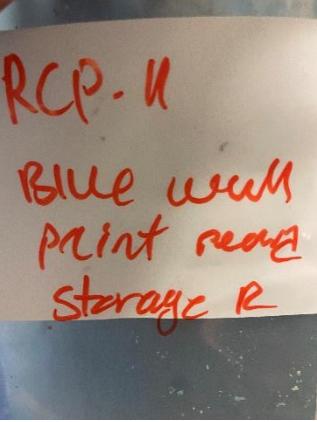
RCP-11	Blue paint / Door surface	1 st Level storage room	0.17

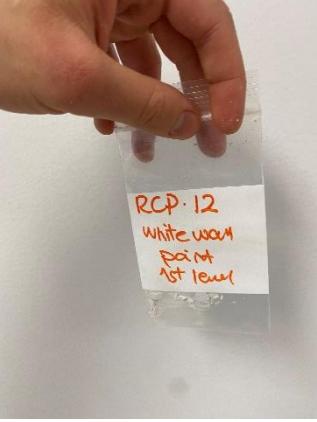
RCP-12	White paint / Wall surface	1 st Level	0.17

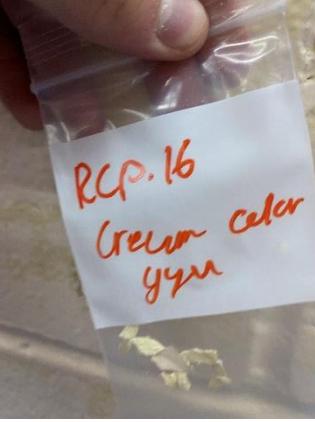
RCP-16	Cream paint / Wall surface	Gymnasium	0.23

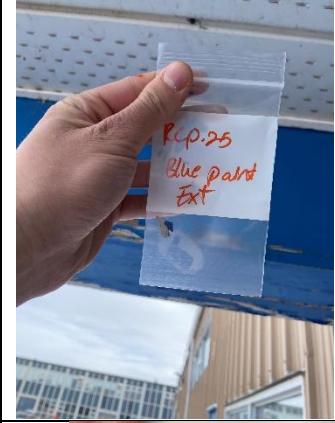
RCP-25	Blue paint	Exterior	0.17

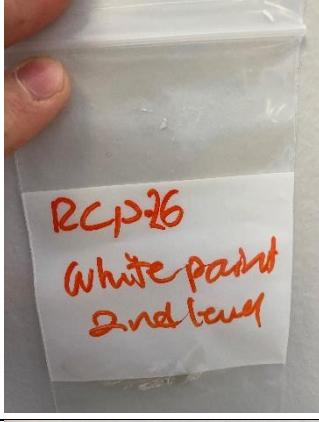
RCP-26	White paint / Wall surface	2nd level	0.26

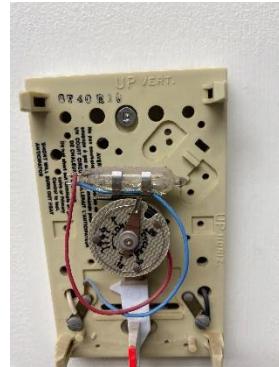
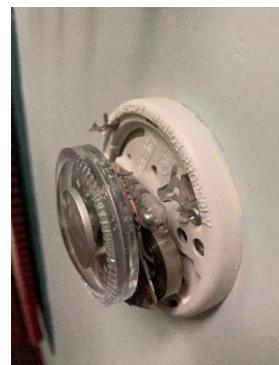
Mercury containing thermostats were observed throughout the building.
