**P.E.I.
Public Forests**

Woodlot Management Plan

Property Number: 225441

Location: Brookvale

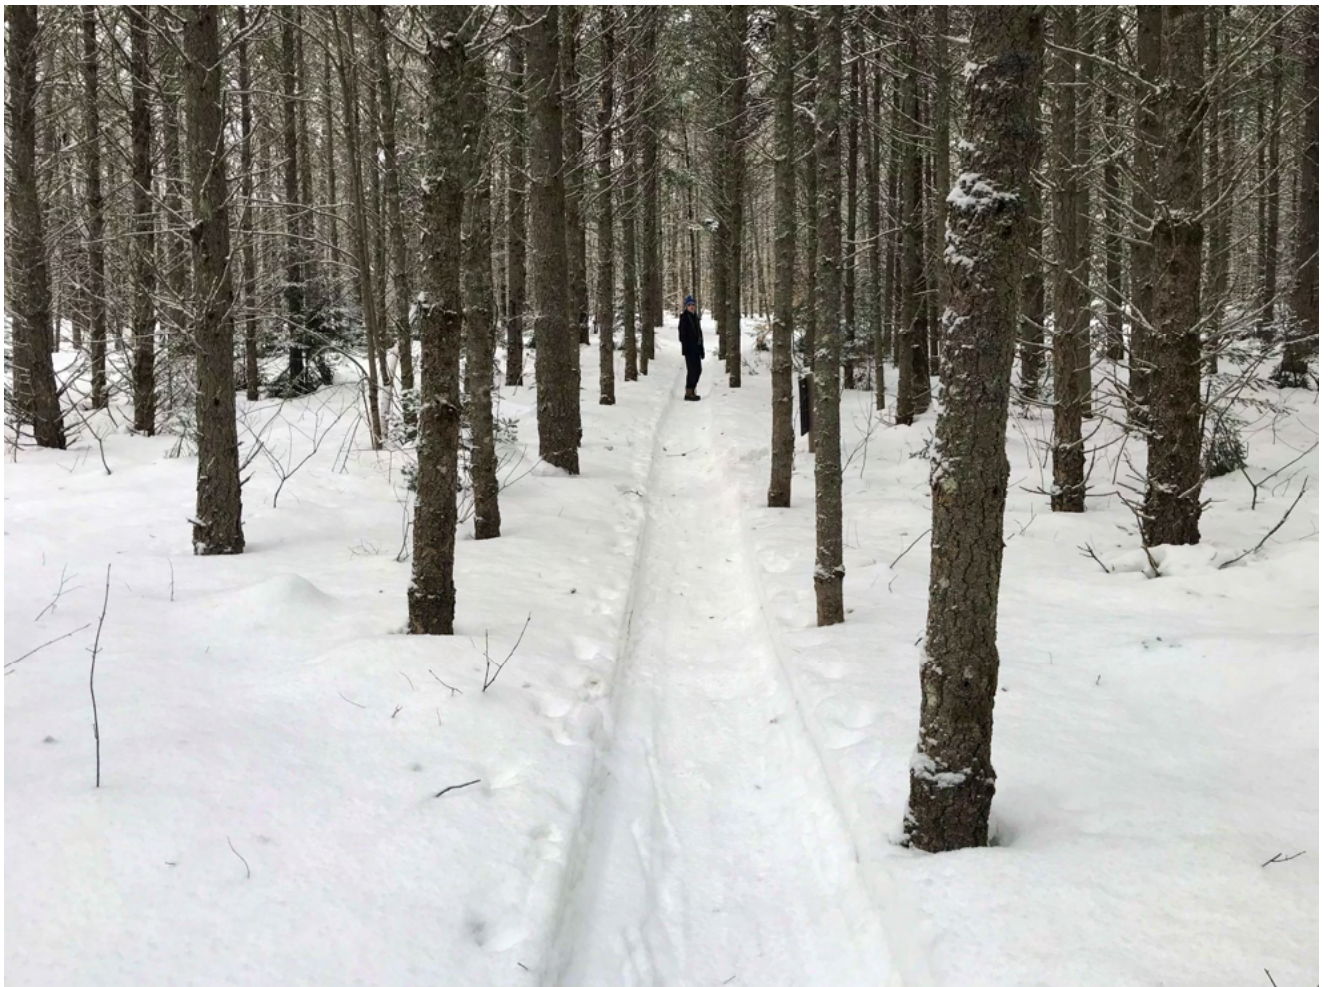
Walking access is provided by a woodland trail system that is approximately 3.9 km in length. The photo below shows a section of the trail during the winter of 2022. Following hurricane Fiona (Sept. 3, 2022), the trail was rerouted to avoid heavily damaged sections.

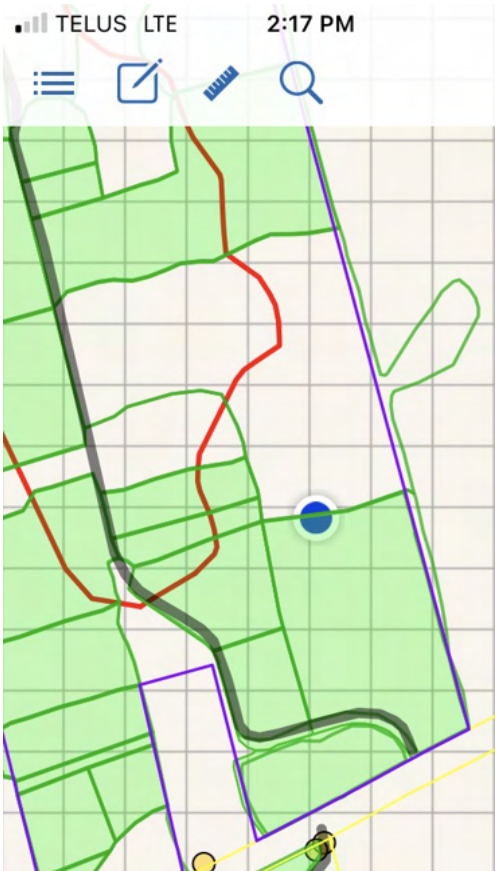
Approximate location of possible glossy buckthorn (invasive species scheduled for removal) in stand #87374.

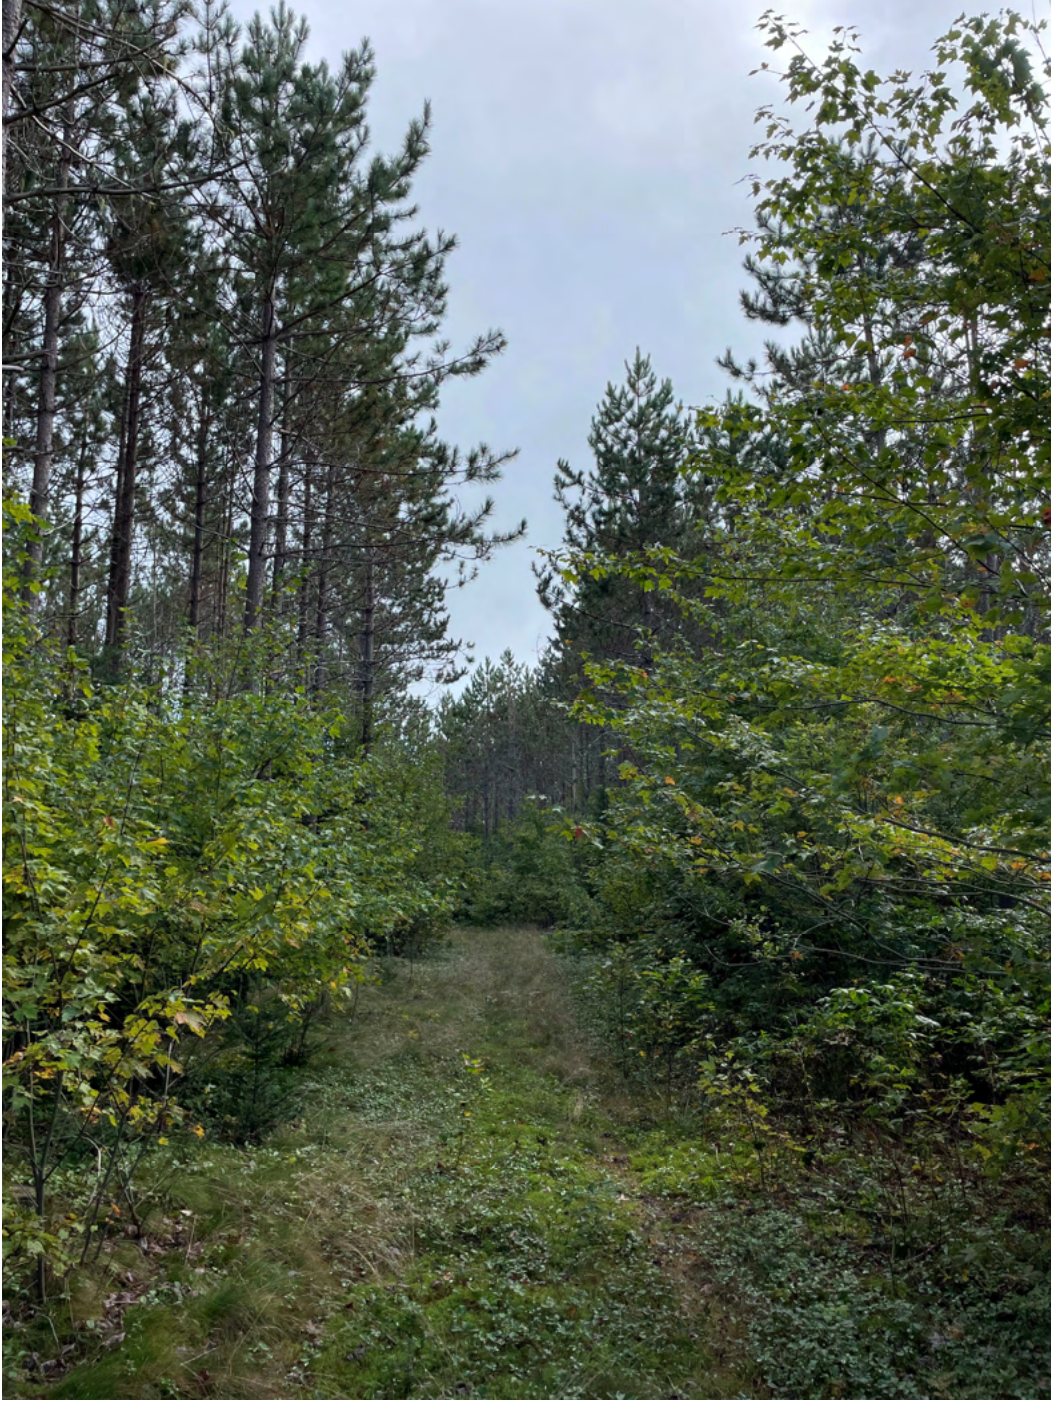
Woodlot road through Red Pine plantation in stand # 871590. This stand as on lower elevation with no exposure to the north. No damage found from hurricane Fiona.

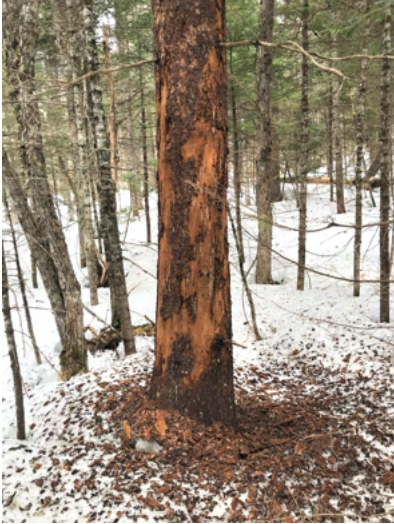
The picture above shows a dead “feeder snag” in stand # 871324 buffer pre-Fiona. This dead White Spruce was infested with bark beetle.

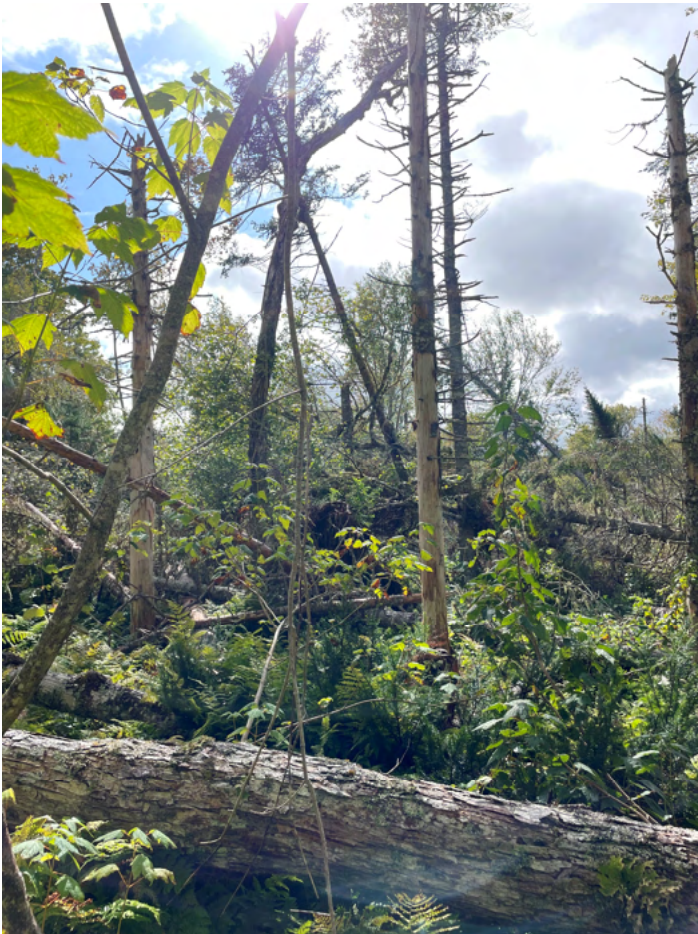
Post-Fiona hurricane damage in the old hardwood stand on a north facing slope (# 871324).
