**P.E.I.**  
**Public Forests**

**Woodlot Management Plan**

**Property Number: 225458**

**Location: Brookvale**

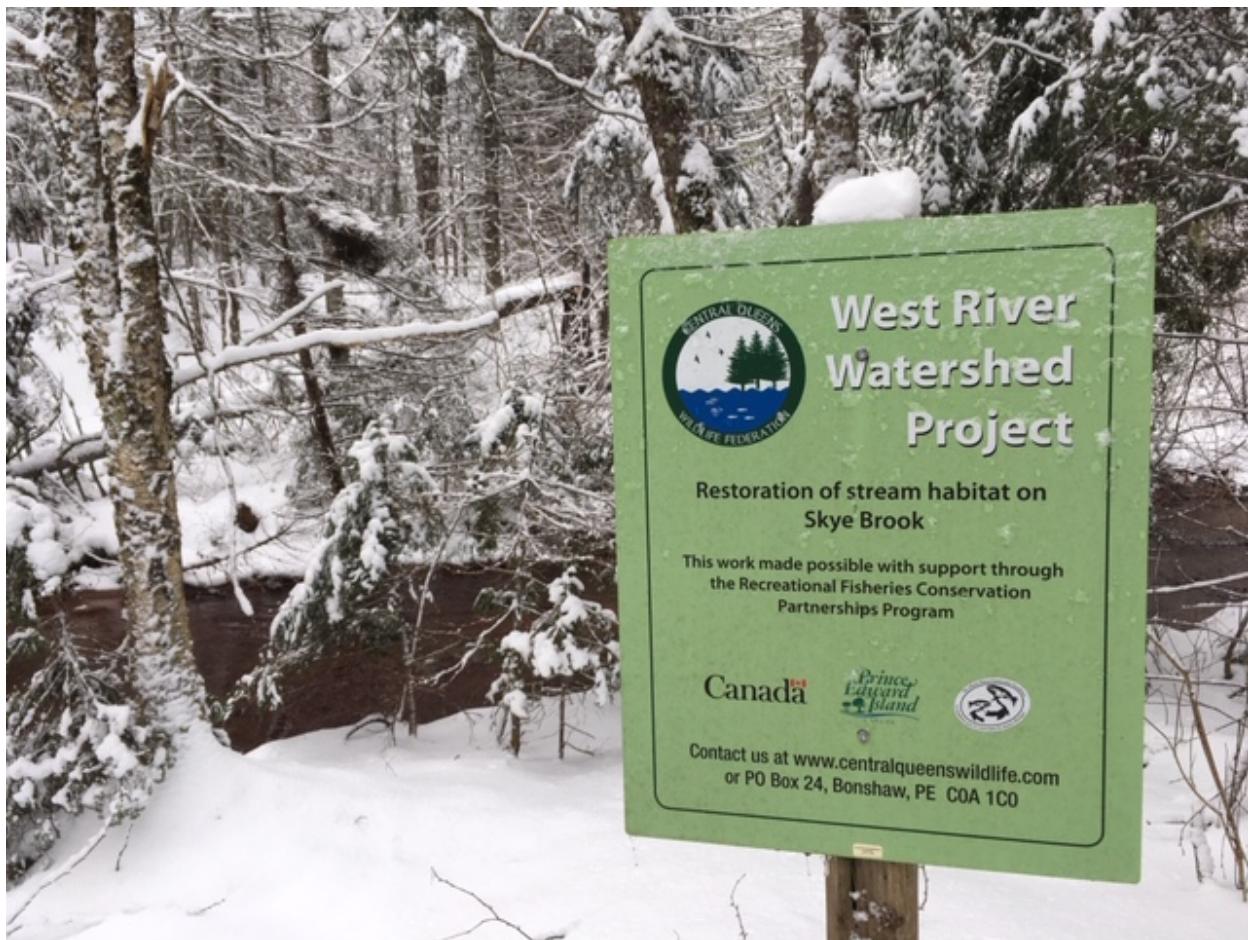
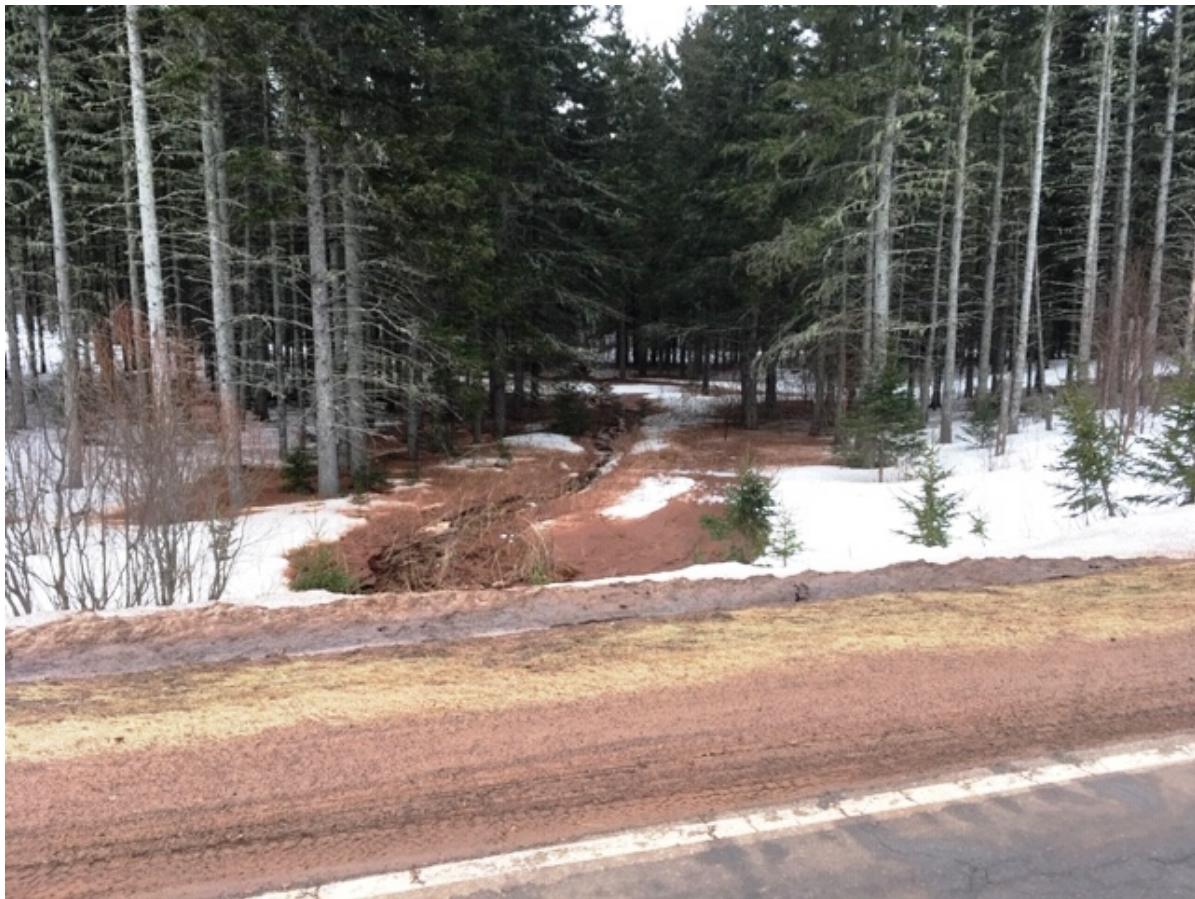
The picture above shows siltation in a drainage gully at the north end of the property following an extreme rain event in 2018. A highway culvert was concentrating flow from adjacent open farm fields to the north of Rte#13. During rain or melt events, the flow carried sediment through the highways culvert onto the woodlot. The Forests, Fish & Wildlife Division brought the issue to the attention of Agriculture, the farmer and Highways officials. A plan was devised to construct erosion control measures on the adjacent farmland to help prevent future issues and protect the woodlot stream.

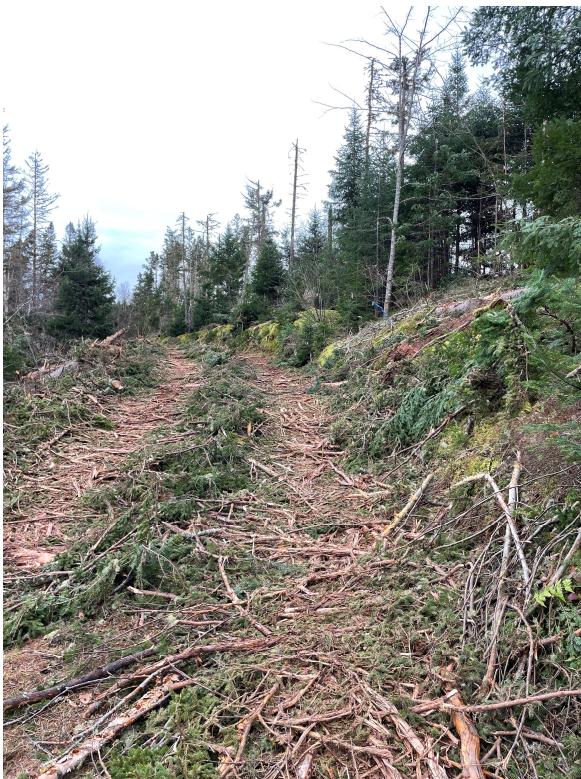
During Fiona salvage operations, brush matting was used on the road surface near the bridge to prevent erosion. The brush layer will be removed from the road surface when sufficiently dry. The brush can be piled in a manner to create wildlife cover and enhance wildlife habitat. Below is a section of road with the brush mat layer in place.

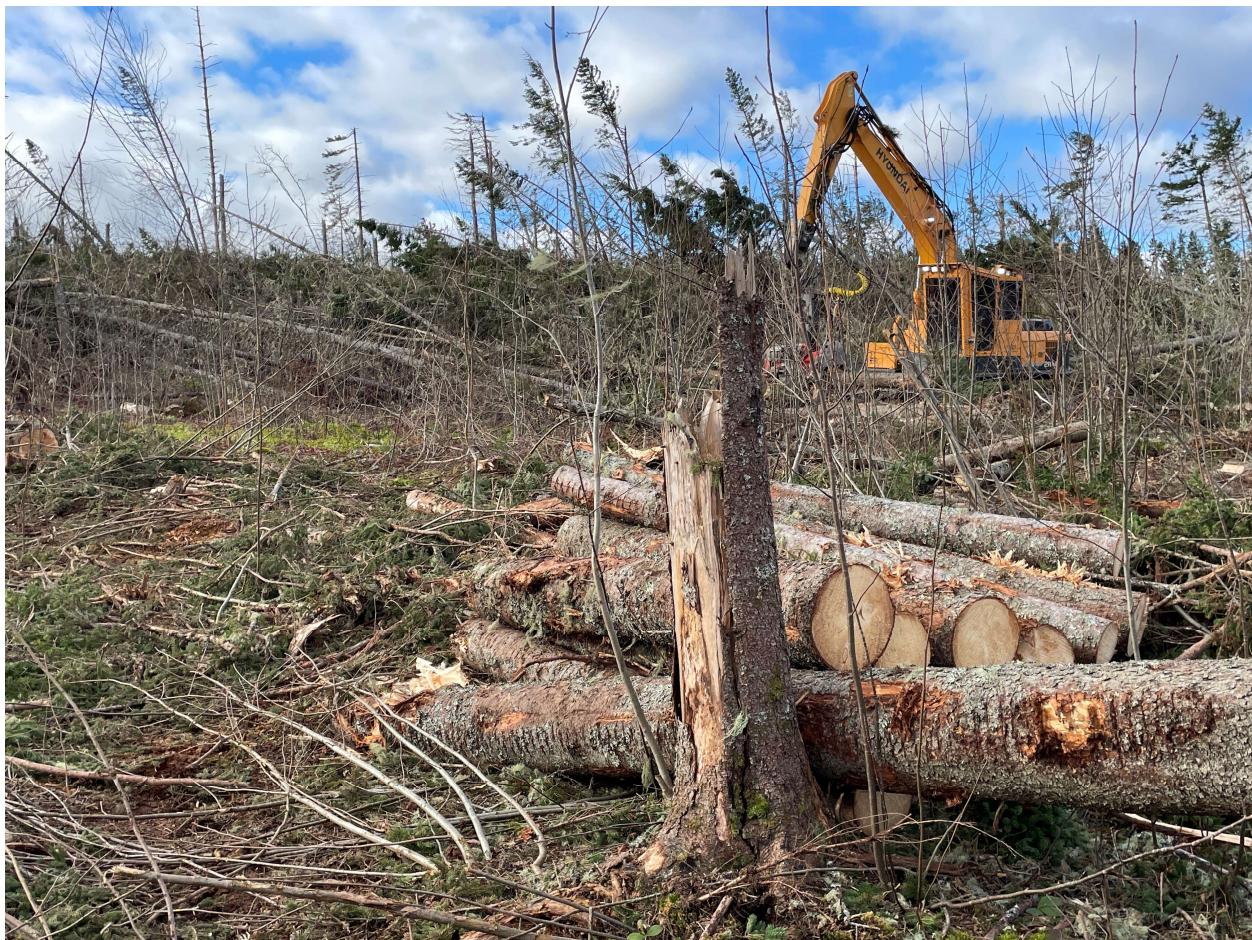
Following hurricane Fiona, the “old field” mature and over-mature timber stands were extensively damaged. Essentially 100% of the trees were blown over or broken off. An emergency salvage harvest was completed to remove timber volume and value, to capture some sequestered carbon, to allow for access for planting, and to mitigate fire risk with the extreme fuel loading. The picture below shows the conditions during Fiona salvage operations in an area that was completely forested prior to the storm.
