CANADIAN CENTRE
for Climate Change
and Adaptation

Prince Edward Island State of the Coast Report

November 2023

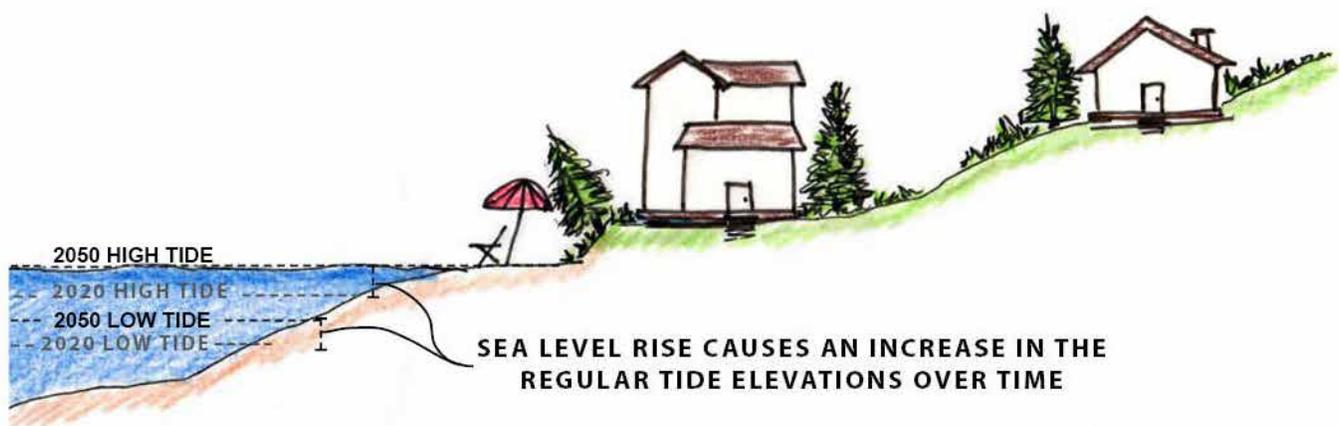
Figure 18. Gradual impacts of sea level rise on the coastal tidal range over time, 2020-2050, shown in still water conditions. (Government of PEI, 2021)

The impact of sea level rise on coastal properties and infrastructure on the Island will depend on the slope and topography of the land in the coastal zone. In areas with steep terrain (i.e., cliffs and bluffs), the shoreline may appear to be relatively unchanged. In low-lying areas, a small rise in sea level can cause permanent coastal flooding and shift the shoreline a significant distance inland.

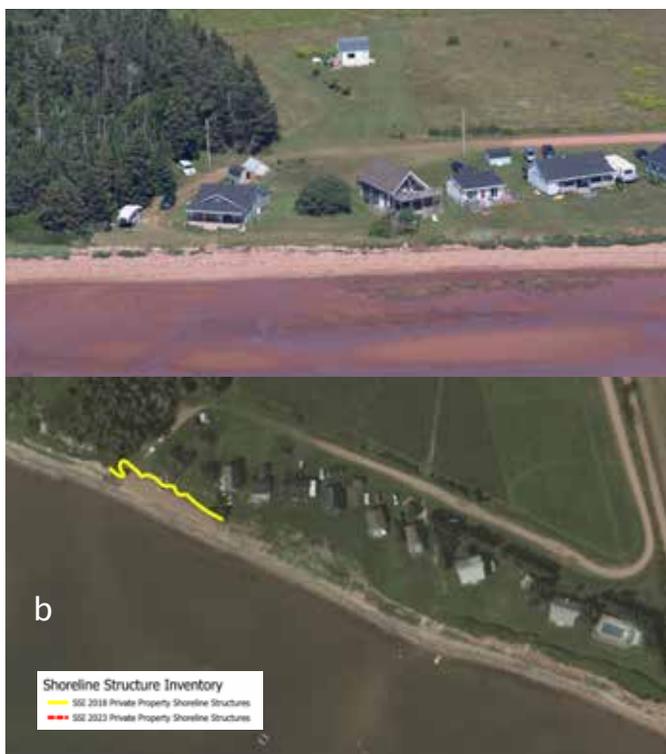
Figure 65. (a) Aerial survey photo of shoreline structures (D. Jardine, 2017); (b) corresponding SSI 2018 map over 2010 orthophoto. Argyle Shore, PE

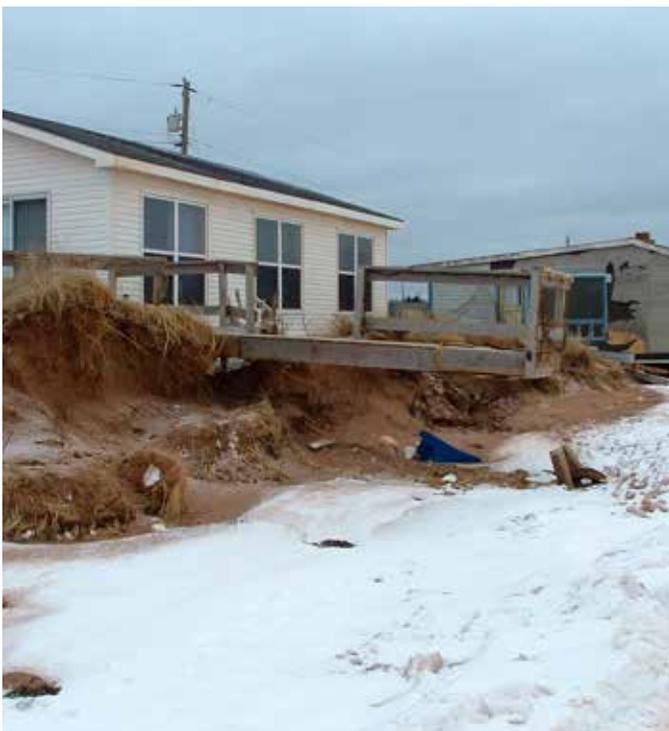
Figure 73. Waterfront cottages damaged in a severe storm event. Maximeville, Egmont Bay PE (D. Jardine, 2006)
