CARDIGAN RIVER FISHKILL 2024

Preliminary Report

March 2025

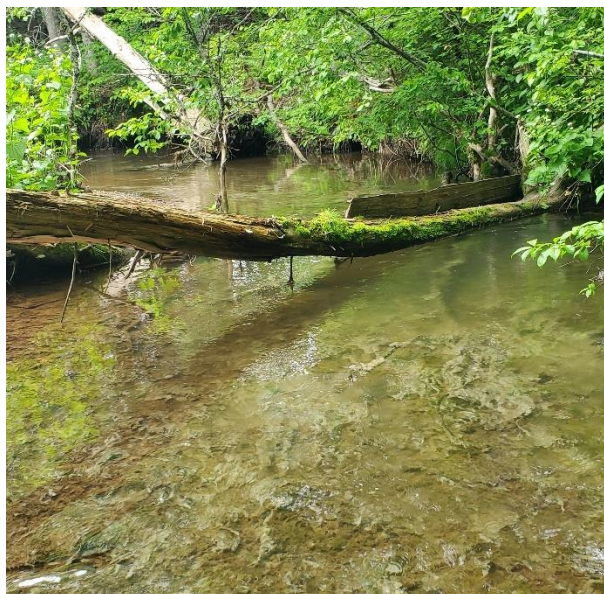
First responders observed that the streambed in the Cardigan River, both upstream and downstream from the 48 Road stream crossing, was covered in a grey, slimy material. This "sludge" was attached to rocks, wood and other vegetation. There was also a putrid odour akin to sewage throughout the stream. During their initial assessment, a number of dead fish were collected immediately downstream from the 48 Road culvert. Photos taken during the investigation and clean up are presented in Appendix I.

Cardigan River downstream from 48 Road. June 7, 2024.
Substrate was covered with a grey slimy material.

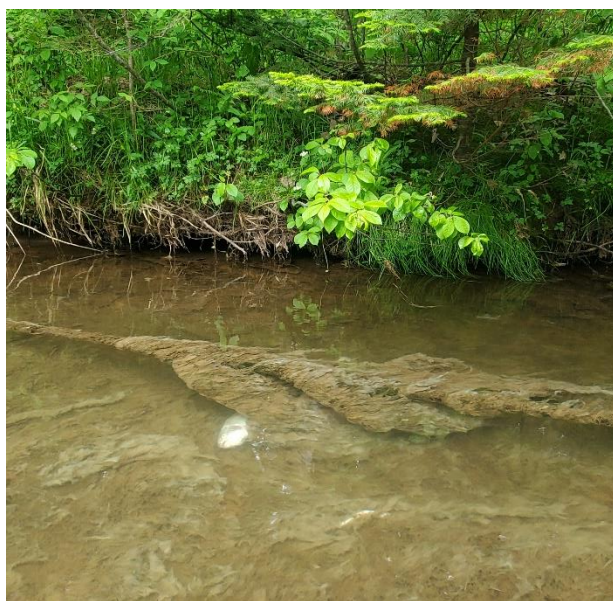
Dead trout in the pool below the 48 Road. Cardigan River, June 7, 2024.

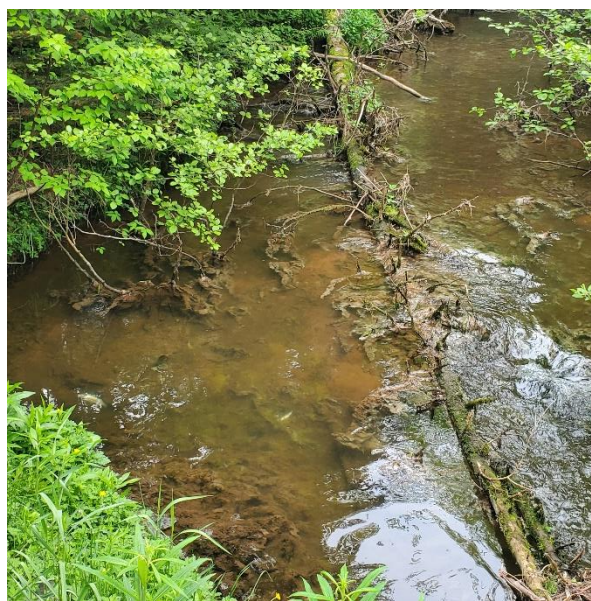
Dead trout visible on the stream bed immediately upstream from the 48 Road culvert. June 7, 2024.

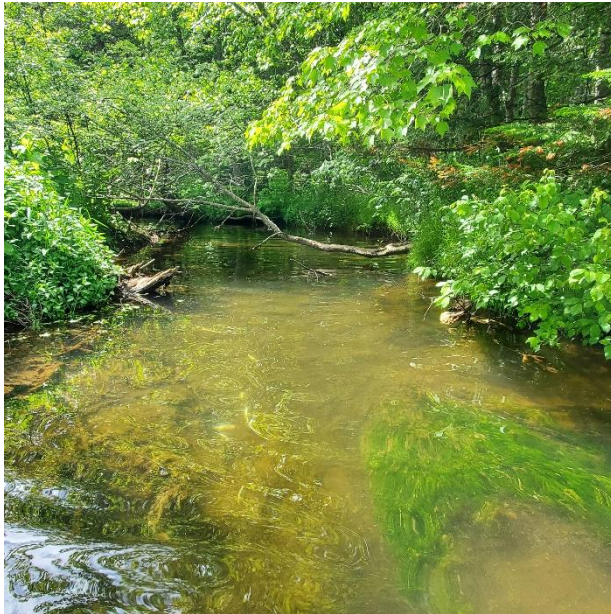
Dead fish on the stream bottom downstream from the 48 Road, Cardigan River. June 7, 2024.

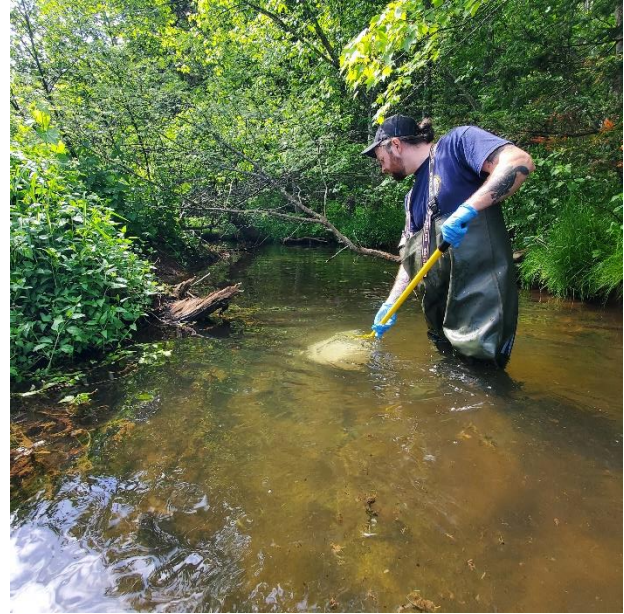
Wildlife technician collects dead fish downstream from the 48 Road, Cardigan River. June 7, 2024.

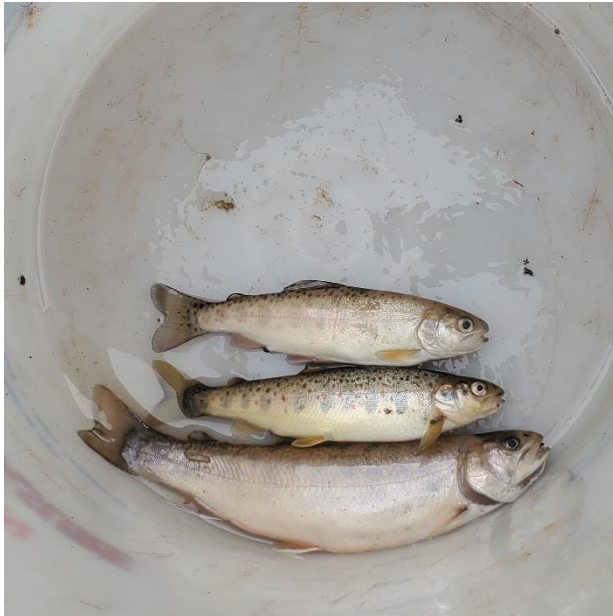
Rainbow trout, Atlantic salmon and brook trout collected in Cardigan River. June 7, 2024.

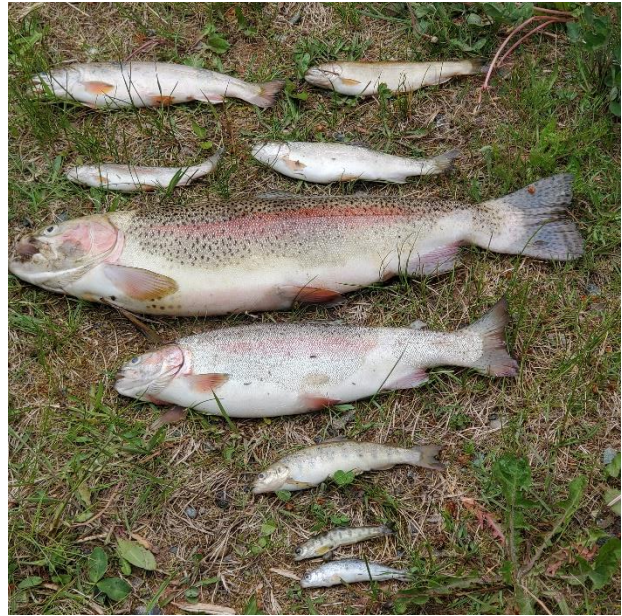
A variety of fish species and sizes collected in Cardigan River. June 7, 2024.

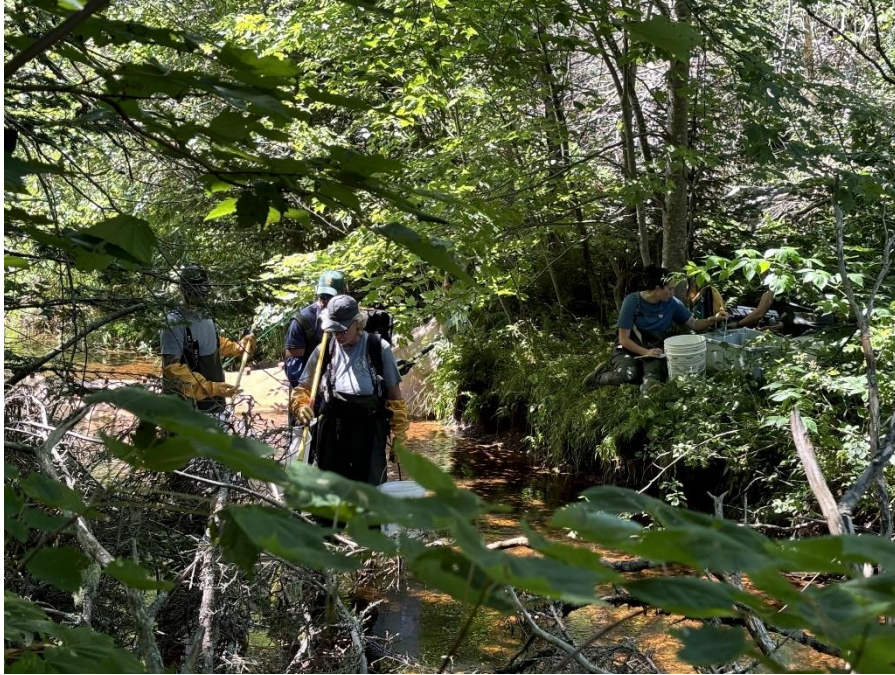
Electrofishing survey on Cardigan River. July 19, 2024. *Photo: Southeast Environmental Association.*

The Forests, Fish and Wildlife Division carried out fish population assessments at three locations. Two sites were surveyed on July 19, 2024 – one site upstream from hatchery inputs and another immediately upstream from the 48 Road. A third site downstream from the 48 Road was surveyed on July 23, 2024. Fish were captured using a Smith-Root LR-24 backpack electrofisher and a three-pass removal technique with barrier nets at upstream and downstream boundaries of the site. The density of fish per 100m² was determined using the Zippon method.

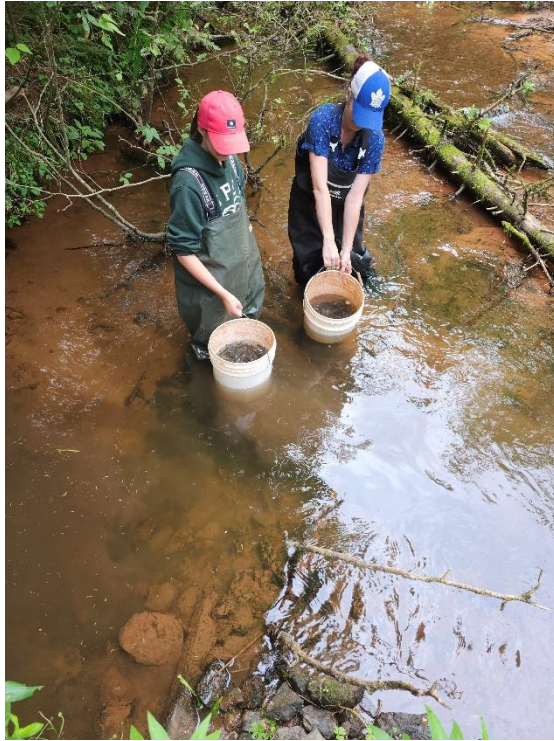
Crew members of Southeast Environmental Association helping to stock brook trout fingerlings into Cardigan River. July 23, 2024.

On July 23, 2024, staff from the Forests, Fish and Wildlife Division, Abegweit Biodiversity Enhancement Hatchery and the Southeast Environmental Association stocked 4000 brook trout fingerlings into Cardigan River (Appendix V). These fish, offspring from Brudenell River broodstock, were produced at the Abegweit Biodiversity Enhancement Hatchery in Scotchfort. Half of the fish were stocked downstream from the 48 Road and the remaining fish stocked between the 48 Road and the private stream crossing below the hatchery.
