MONTROSE RIVER FISHKILL 2020

Preliminary Report

November 2020

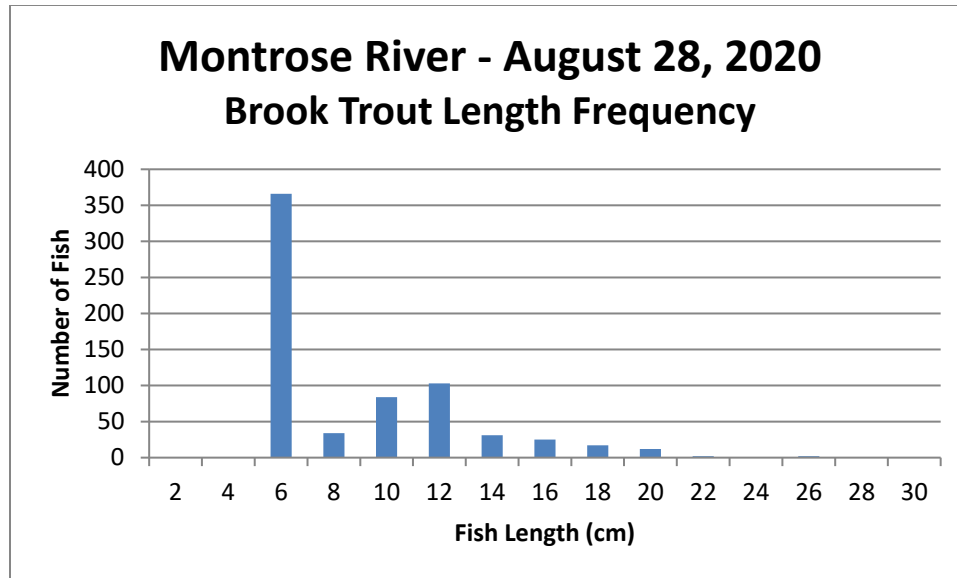
Figure 2. Length frequency graph for 679 brook trout collected in Montrose stream, August 28, 2020.

Length measurements were obtained on 679 of the fish collected on August 28. Brook trout fry (<8 cm) made up over half of the total fish collected (Figure 2). These were not measured but were assigned an average length of 5.3 cm, as determined by measuring lengths in a subsample of fish.

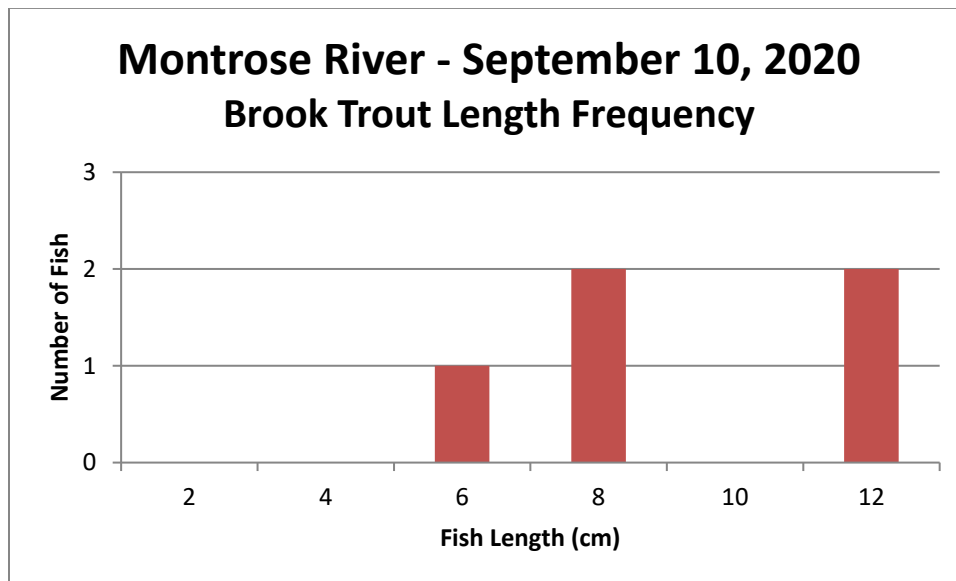
Figure 2. Brook trout length frequency graph for Montrose River, September 10, 2020.

trout were found in a 135 m² section, representing a density of 3.9 trout/100m². The density is much lower than what would be expected in a stream of this size. In Prince Edward Island streams, it is normal to get over 50 trout/100 m² and densities exceeding 400 trout/ m² have been recorded.

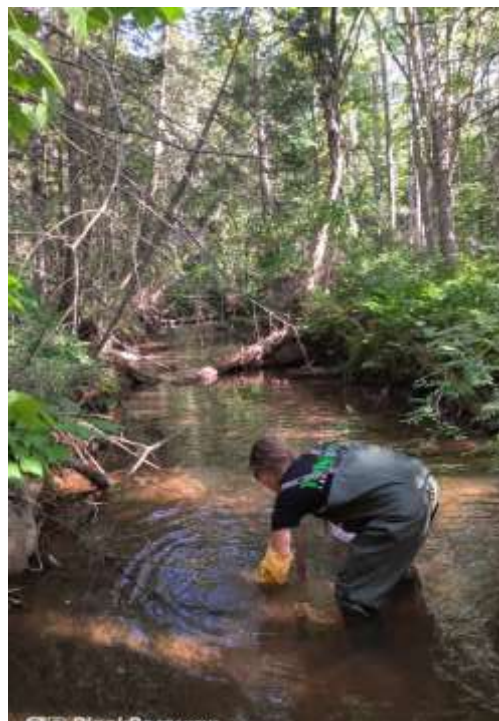
Photo 2. Wildlife technician (EWCC) collects dead fish in the Montrose River. August 28, 2020.

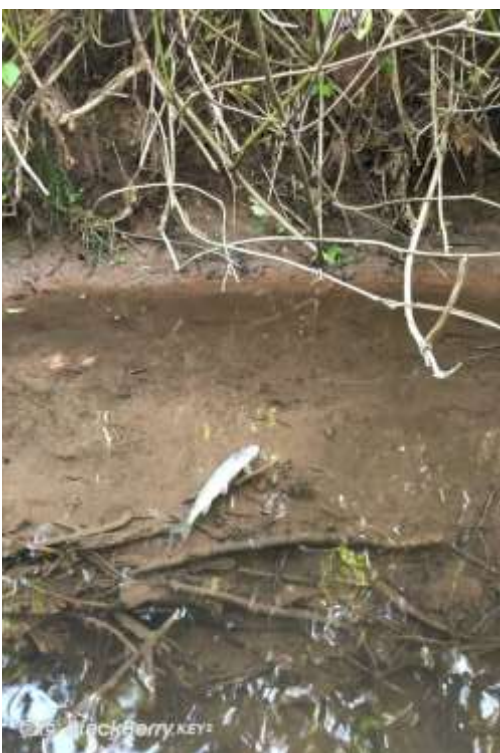
Photo 3. Dead brook trout in Montrose River. August 28, 2020.

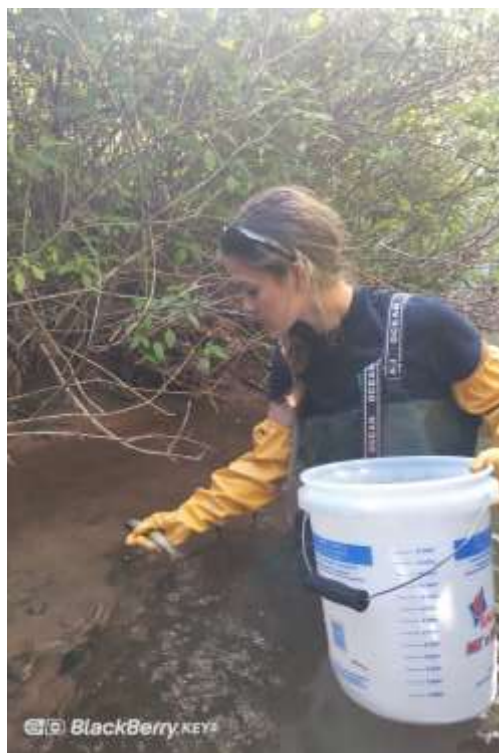
Photo 4. Wildlife technician (EWCC) collects brook trout in Montrose River. August 28, 2020.

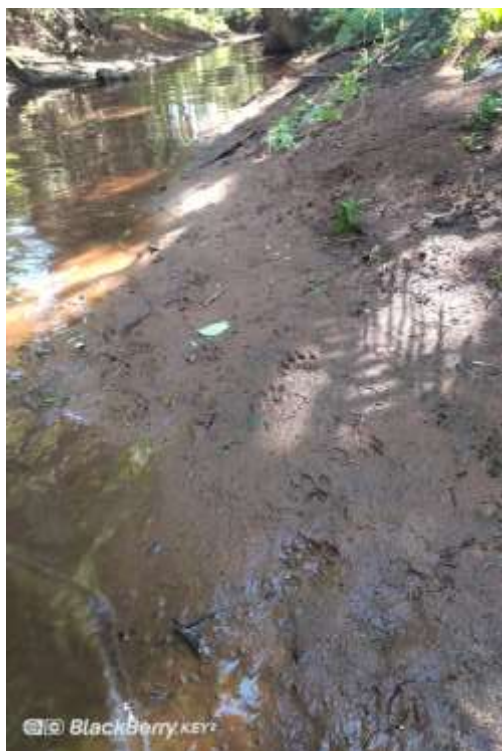
Photo 5. Raccoon tracks next to Montrose River. August 28, 2020.

Clean-up of dead fish on the Montrose River was completed on August 28-29, 2020, with a total of 2057 brook trout collected. On August 28, the Manager of Investigation and Enforcement (DJPS) and the Environment officer (ECCC) collected 228 brook trout from Route 2 to the Confederation Trail, of which 15 were taken to the Environment and Climate Change Canada laboratory for analyses. The Freshwater Fisheries Biologist and Wildlife Technician from the Department of Environment, Water and Climate Change collected 679 brook trout and 1 stickleback upstream from Marchbanks Pond. On August 29, two employees of the Cascumpec Bay Watershed Association completed the clean-up by collecting 1150 brook trout downstream from Route 2. Some live fish were observed and a small number of moribund fish were found. Many of the smaller fish in deeper water were unable to be retrieved and many partial carcasses of trout were observed during the clean-up. There was also an abundance of raccoon and great blue heron tracks observed in the stream bottom and floodplain.

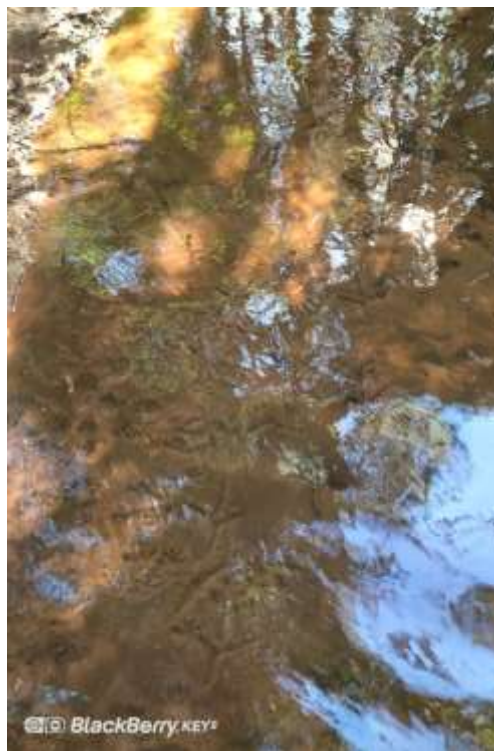
Photo 6. Great blue heron tracks in the Montrose River. August 28, 2020.

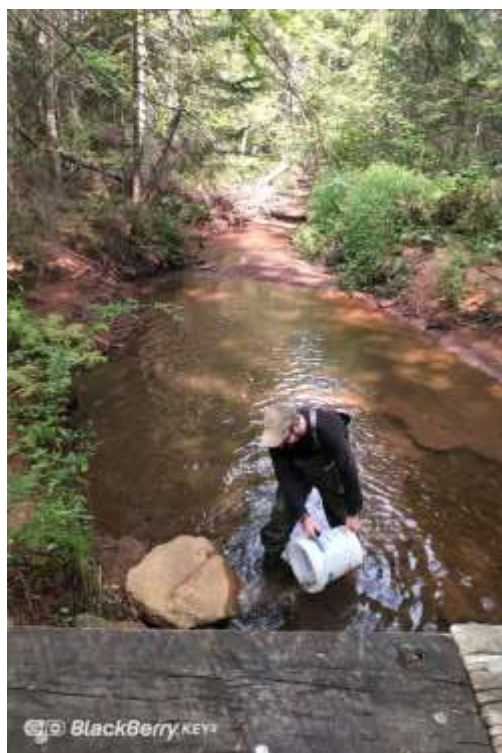
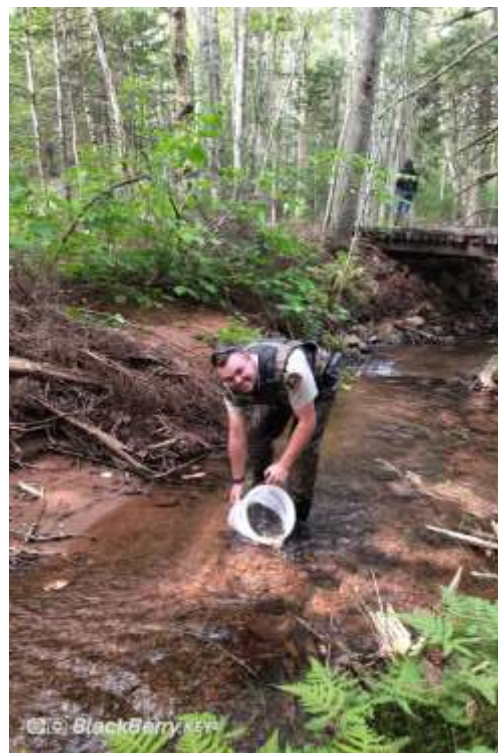
Photos 7-8. Stocking brook trout fingerlings into Montrose River. September 15, 2020.

On September 15, 2020, the Department of Environment, Water and Climate Change - Forests, Fish and Wildlife Division - stocked 3700 fall fingerling brook trout into Montrose River. These fish, offspring from Trout River broodstock, were produced at the Abegweit Biodiversity Enhancement Hatchery in Scotchfort. Half of the fish were stocked in the area of a private stream crossing midway between Marchbanks Pond and Route 2; the remaining fish were stocked at a private crossing closer to Route 2.
