ANNUAL REPORT

RPAS Erosion-Mitigating Infrastructure
Monitoring of 8 Sites on Prince Edward
Island

2021-2022

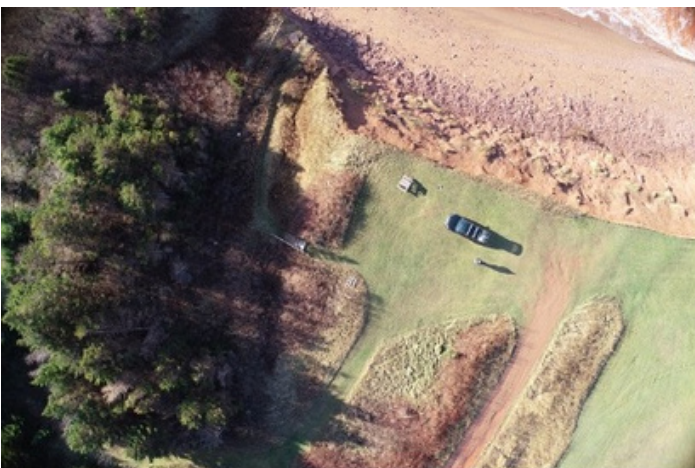
Fig 3. Nadir photo (left) vs. Oblique photo (right)

Once the GCPs are laid, the RPAS flight can begin. The DJI Phantom 4 RTK has on-board RTK, so if a strong cellular connection is available, a WiFi hot spot can be created using an available cell phone, to which the RPAS connects to and waits for the RTK to lock. Once connected, the RTK connection allows the RPAS to tag the resulting photos with accurate locations, generally within 2-4 cm accuracy. While on-board RTK can deliver excellent horizontal (X,Y) accuracy, the vertical accuracy (Z) is often less than desired, so GCPs are still used to improve vertical accuracy. In some areas of PEI, most notably areas along the Western coast and along the North shore of Kings County, cellular connection is often too poor to connect to RTK. Once RTK has been connected or turned off due to connection issues, the RPAS pilot uploads the flight plan and launches the RPAS. The RPAS flies the pre-programmed mission while the pilot monitors the remote controller screen and a visual observer keeps visual contact on the RPAS. The RPAS pilot and the visual observer communicate via walkie-talkies and stay connected throughout the flight to provide constant updates. Once the programmed flight finishes, the pilot then takes manual control and takes a series of oblique photos, which are photos taken at a 60-70 degree angle. Nadir photos are also taken during the mission, at around 90 degrees.

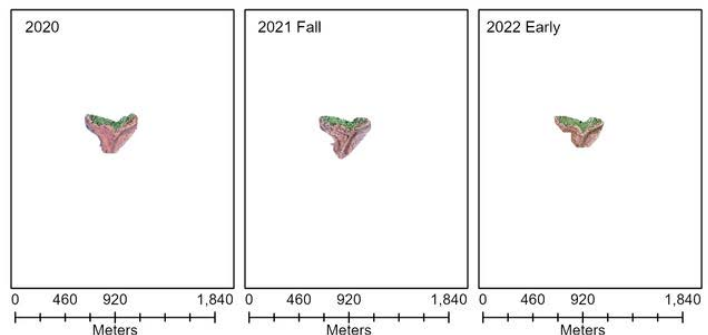
Fig 12. Output map for Cape Traverse site, from 2020-2022

The EPR between the July 5th and October 31st flights was found to be -3.54 m/year and the NSM was found to be -1.14 m.

The EPR between our first flight in 2020 and most recent flight was found to be -0.92 m/year and the NSM was found to be -1.91m.

Erosion is evident behind the armouring and after Fiona some sections of armouring have been scattered.

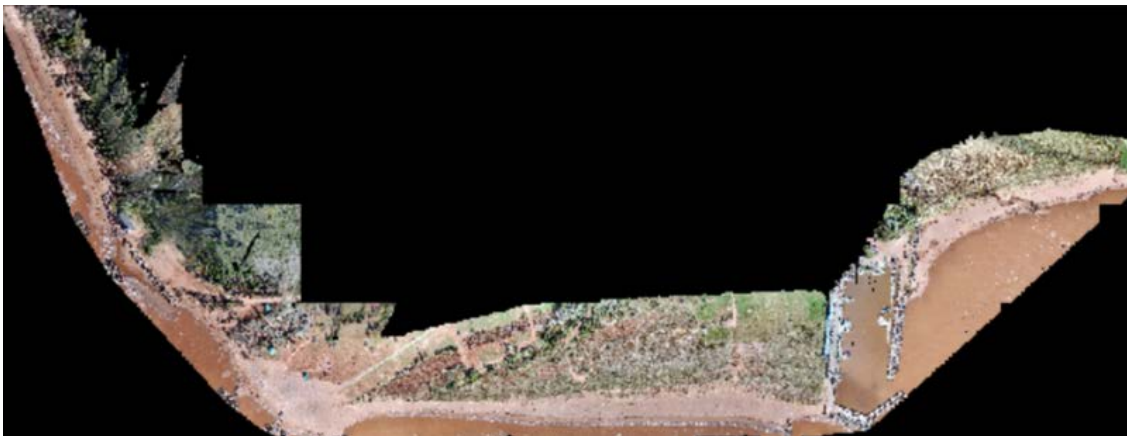
Fig 14. Orthomosaic of Cedar Dunes & West Point Lighthouse from October 12th RPAS flight

Armouring present:

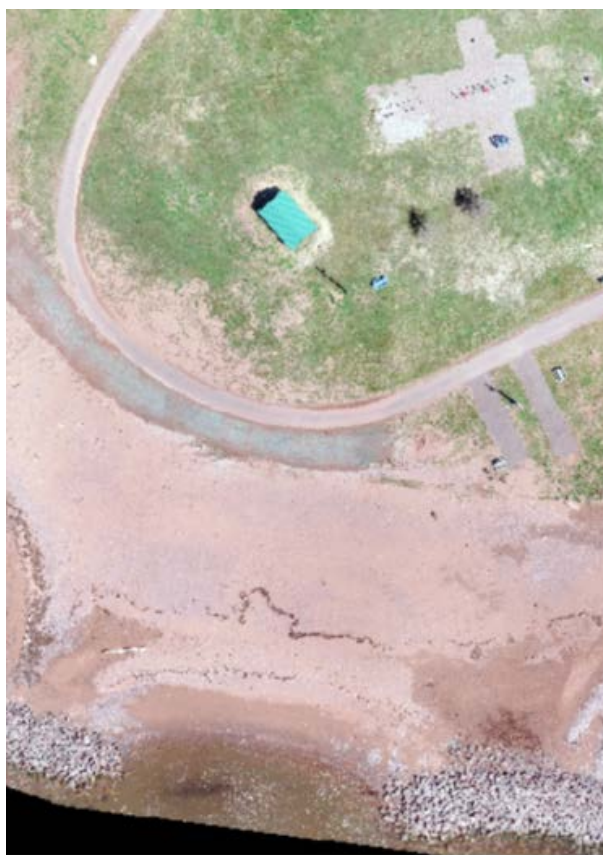
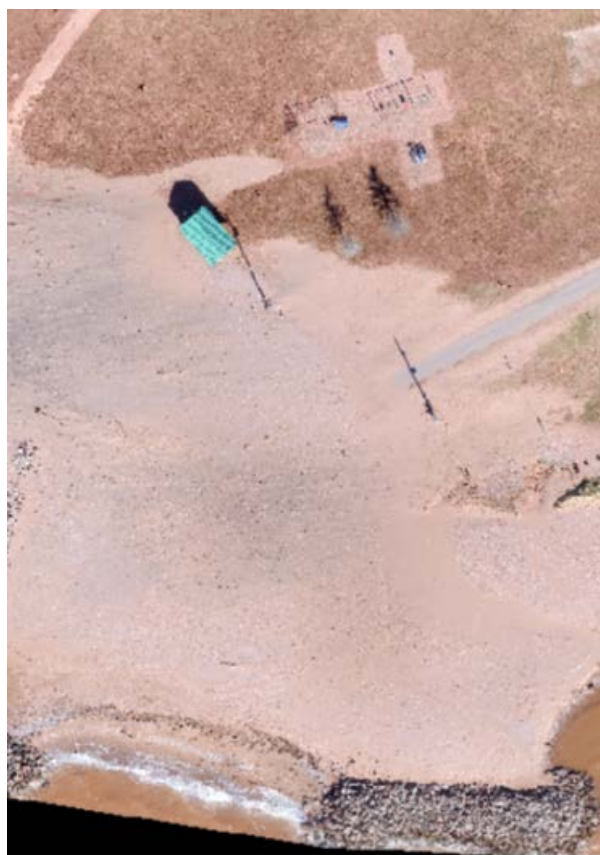
Fig 15. Section of Cedar Dunes coastline from June (left) and October (right) showing coastal changes

- A larger area was flown and delineated Post-Fiona, including the harbour.
- No significant changes from October 2021 - June 2022.
- Some marram grass growth from October 2021 - June 2022.
- There was significant erosion and loss of vegetation post-Fiona.
- Nearly 30m of change from June 2022 - October 2022 in some areas.
- There appears to be some sand accumulation near the coastal reefs (breakwaters).
- Significant erosion occurred around a facilities building which now appears to be on the new beach area and is located behind the coastal reef installation.

In 2022, the EPR between the June 15th and October 12th flights is -16.01 m/year and the NSM is -5.22 m.

The EPR between the first flight on September 25th 2020 and the most recent flight on October 12th 2022 is -2.86 m/year and the NSM is -5.85 m.

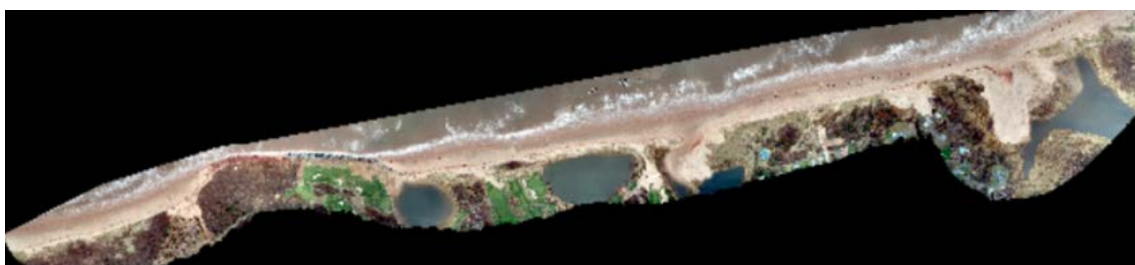
Fig 18. Orthomosaic of Crowbush from November 11th 2022 RPAS flight

Armouring present:

Between the October 20th 2021 flight and November 11th 2022 flight, the EPR is -9.04 m/year and the NSM is -9.27 m.

The EPR between the first flight on October 13th 2020 and most recent flight on November 11th 2022 is -4.24 m/year and the NSM is -8.81 m.

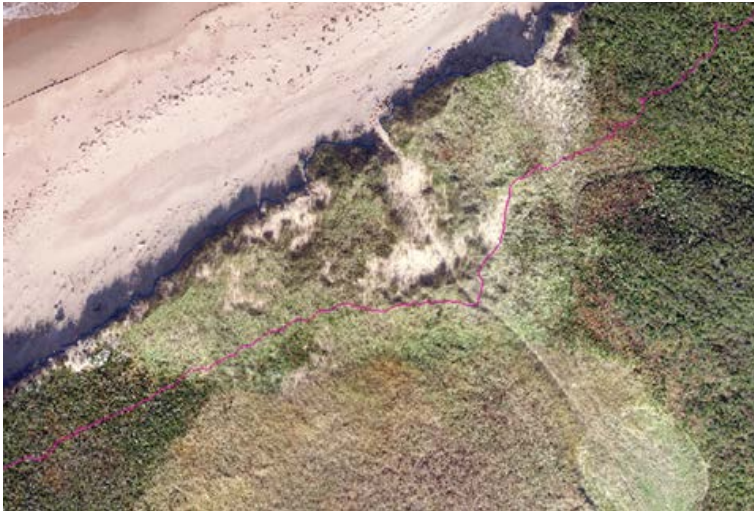
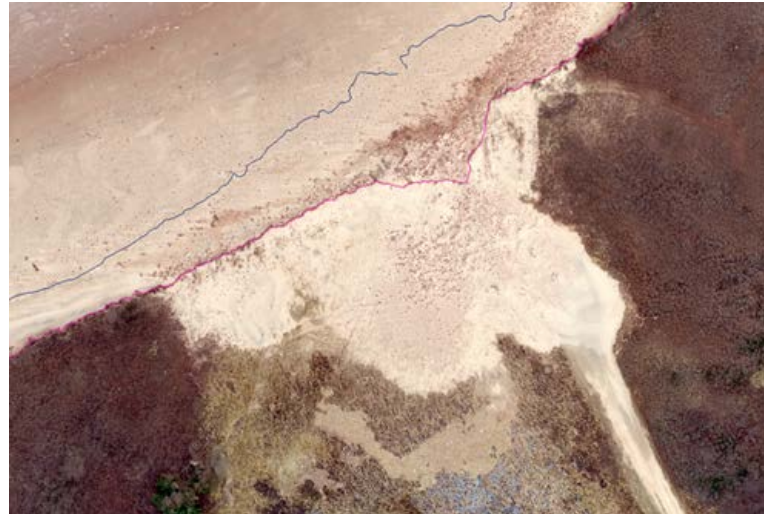
Fig 19. Section of Crowbush coastline from 2021 (left) and 2022 (right) showing coastal changes

- A larger area was flown and delineated in 2022.
- Crowbush experienced significant erosion Post-Fiona.
- Erosion appears to have occurred behind the armour stone.
- Consistent significant erosion along the entire stretch of the coastline.
- The extended Western section requested within the new Methodology could not be flown due to lack of access (ie. road washout from Post Tropical Storm Fiona).
- The consistent presence of golfers makes this site difficult to fly before late Fall.

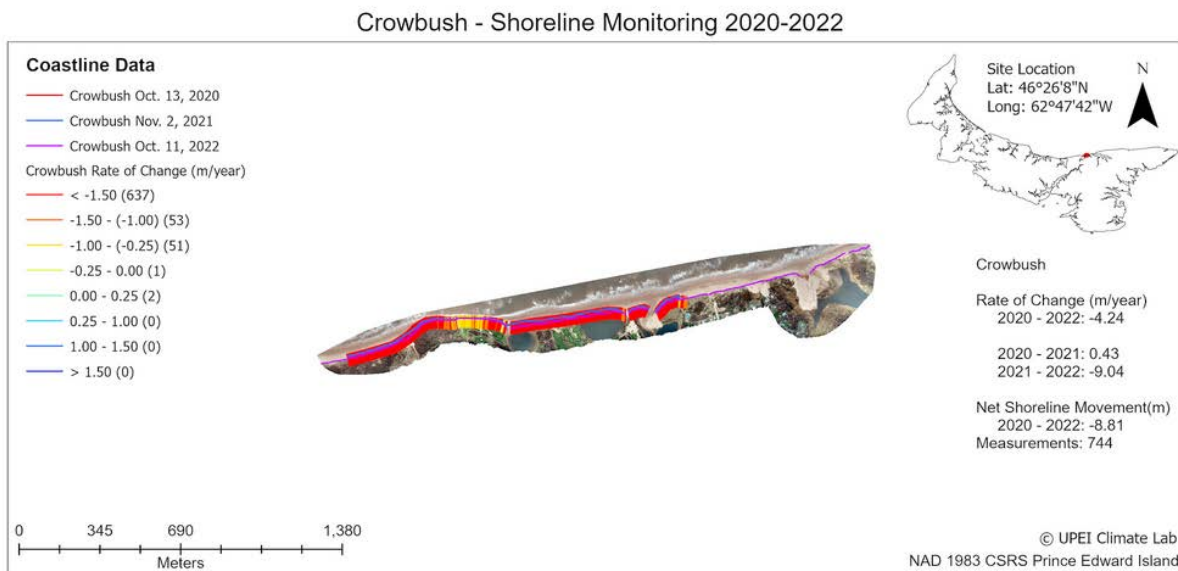
Armouring present:
 Armour stone protecting section of Crowbush golf course.

Site notes:
 The EPR between our first flight and most recent flight was found to be -4.24 m/year and the NSM was found to be -8.81 m. Based on rates at other sites in the area it is likely most of this loss can be attributed to damage from Fiona

A large section has been added to the eastern end of the site. There were access issues preventing extension on the western end of the site. Several pieces of access infrastructure were significantly damaged or destroyed in Fiona.

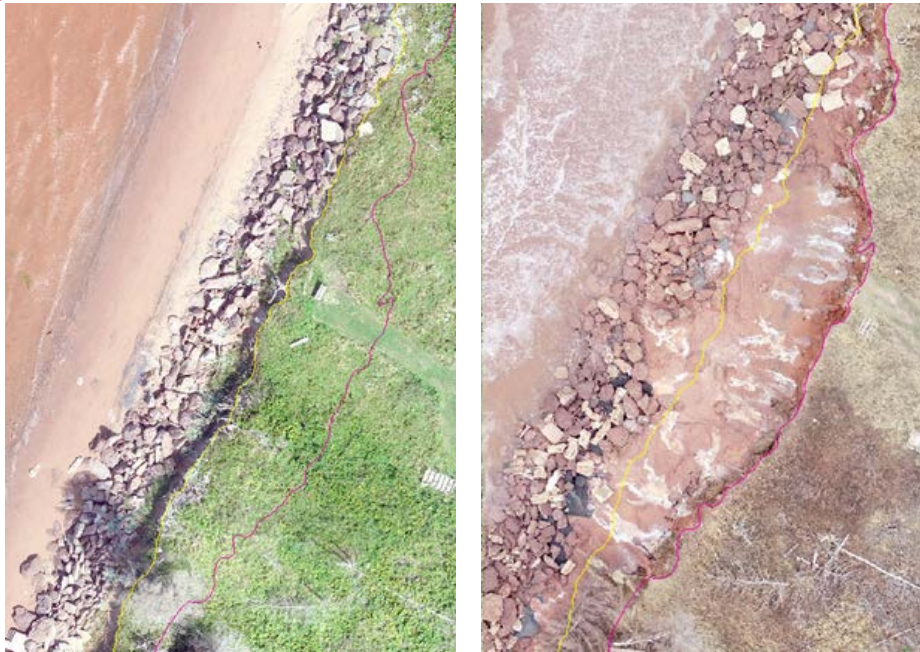
Fig 28. Section of Miminegash coastline from August (left) and November (right) RPAS flights showing coastal changes

- Much larger area flown and delineated Post-Fiona.
- Due to the size of the area, this site is flown in 2 sections (North, South).
- Due to the amount of time required to fly this expanded area, shifting tides can create an issue with flying the entire area at low tide.
- Significant erosion appears to have occurred behind the armour stone (~9 meters in certain areas).
- Some movement and loss of armour stone was observed Post-Fiona.
- Consistent, significant erosion along the entire study area was observed Post-Fiona.

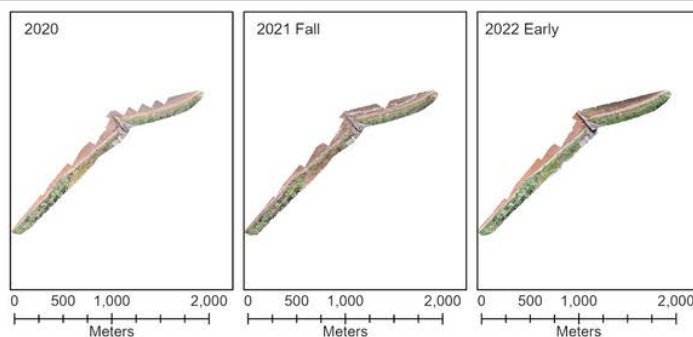
Fig 29. Output map for Miminegash site, from 2020-2022

The EPR between the August 22nd and November 25th flights was found to be -25.68 m/year and the NSM was found to be -6.68 m.

The EPR between our first flight in 2020 and most recent flight was found to be -3.0 m/year and the NSM was found to be -6.44 m.

The area flown at the end of 2022 was significantly larger than previous flights, with 2021 being 108 acres and the August flight being 121. Significant damage to the coastline across most of the site after Fiona. Several areas with armouring had the rocks scattered and experienced erosion and loss behind the armouring

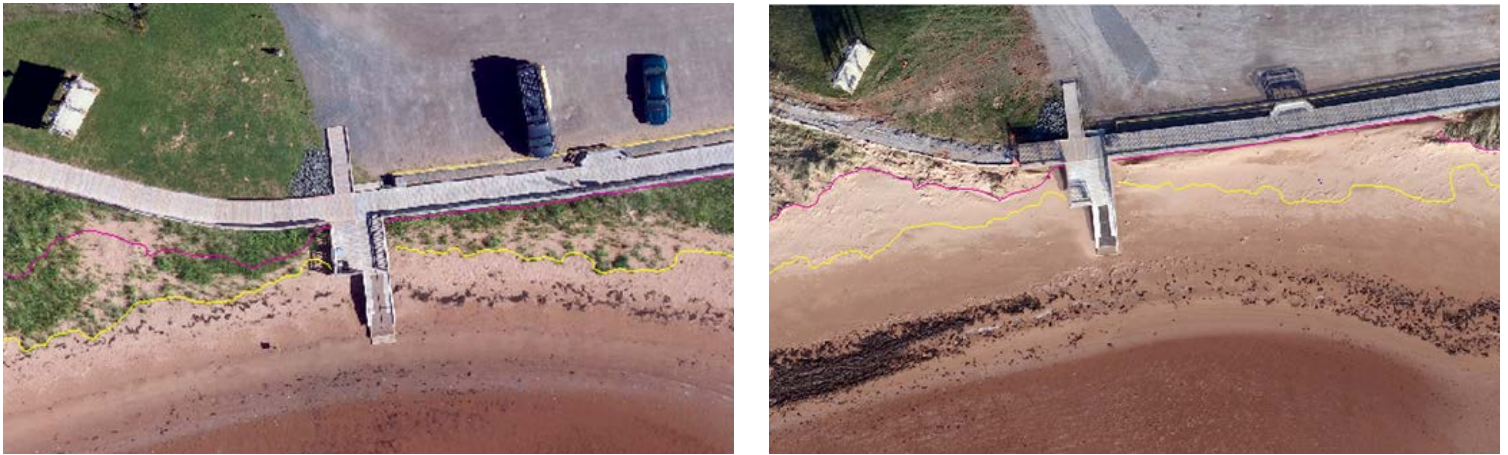
Fig 36. Section of Souris coastline from July (left) and November (right) RPAS flights showing erosion on either side of stairs

- A larger area flown and delineated Post-Fiona.
- November flight ended prematurely due to minor damage to the RPAS. This means the angled (oblique) section of the flight was incomplete. However, the full area was still captured during the Nadir section of the flight and was still able to be processed.
- More sand appears to be building up on beach behind coastal reef.
- The unprotected shoreline experienced consistent erosion Post-Fiona.
- Most significant loss occurred in front of the board walk on either side of the stairs.

The EPR between our first flight on October 1st 2020 and most recent flight of November 19th 2022 is -2.32 m/year and the NSM is -4.94 m.

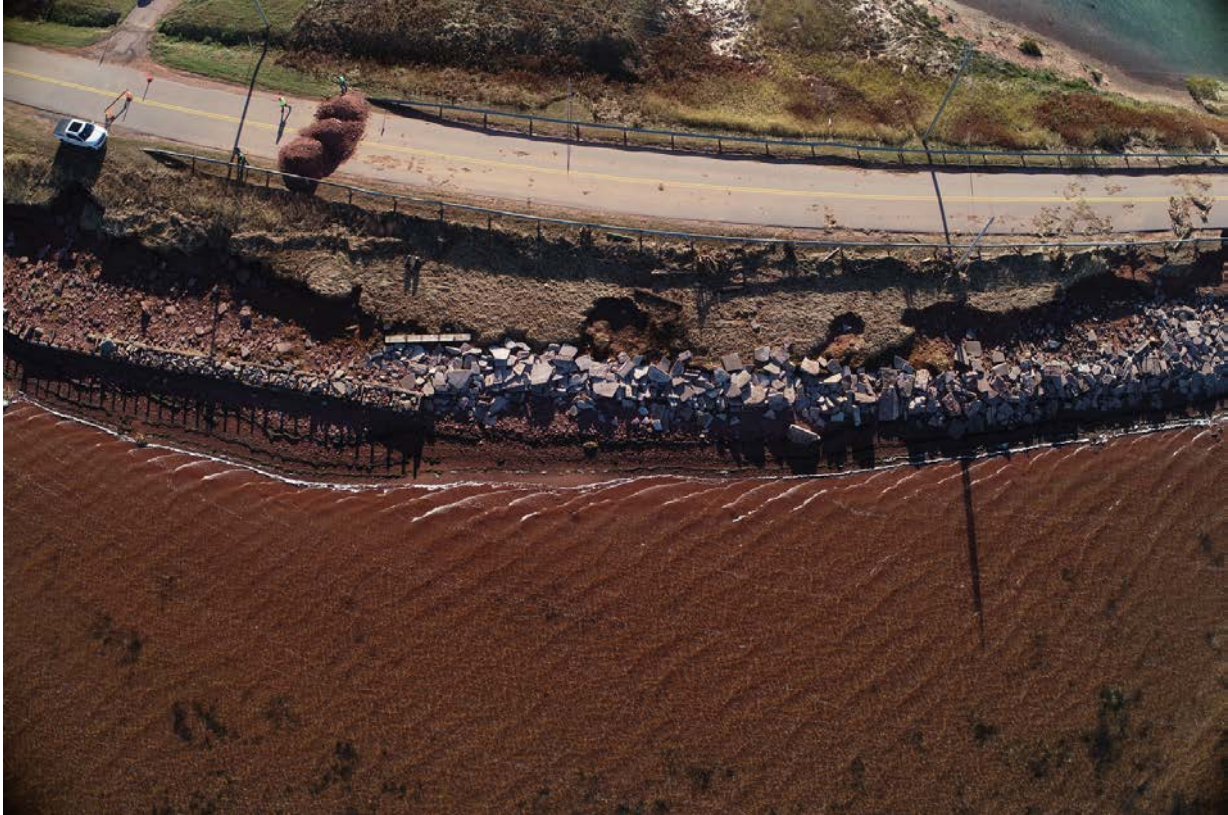
While none of the 8 monitoring locations experienced significant infrastructure damage, numerous bridges and roads were closed on PEI in the aftermath of the storm, and many harbours had extensive damage.

Fig 39. Reuben's Lane bridge closed after Post Tropical Storm Fiona

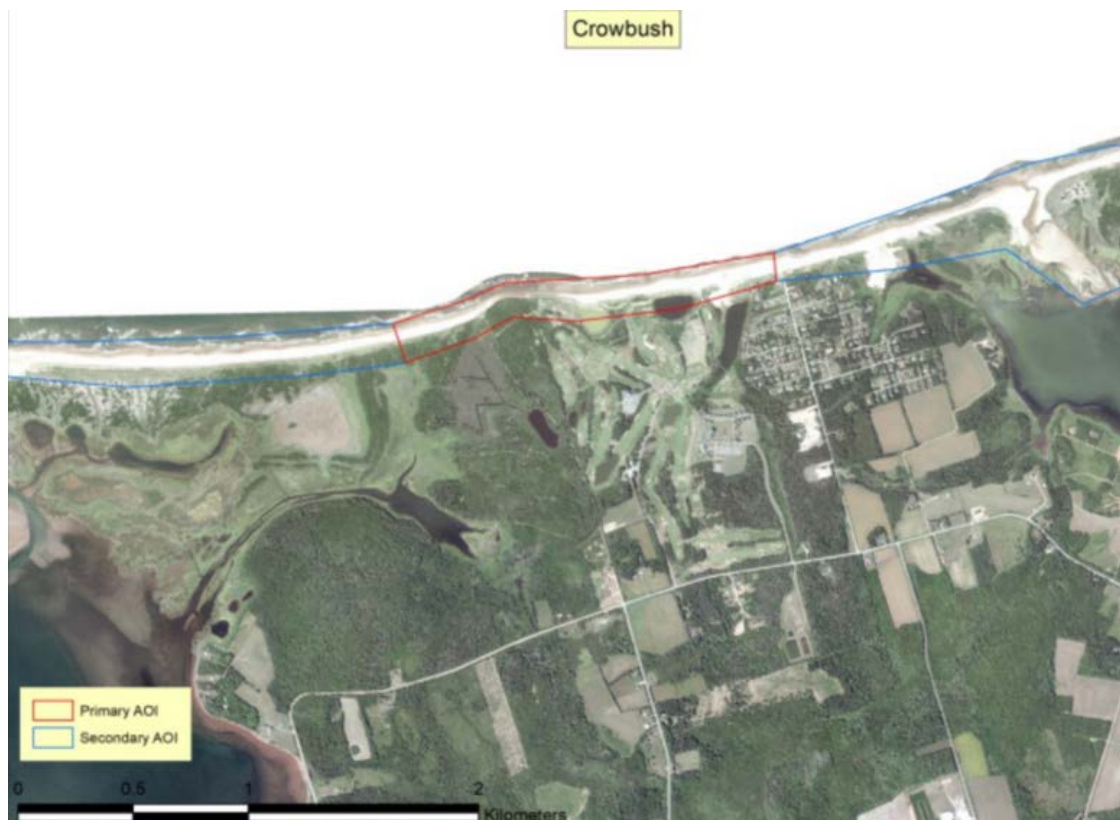
At Crowbush, there was no access to the western secondary area of interest due to a road washout (MacAdam Road) just west of Crowbush's entrance. Without this road access, it is impossible to reach the requested area - even alternative routes such as walking around the armour stone section or scaling the cliff to get onto the western shore are no longer an option. Staff at Crowbush golf course indicated that MacAdam Road now goes through a resident's property, so it is unclear if it would be accessible moving forward. During the 2023 flying season, the availability of MacAdam Road should be explored further.

Fig 41. Primary (red) and secondary (blue) areas of interest at Crowbush

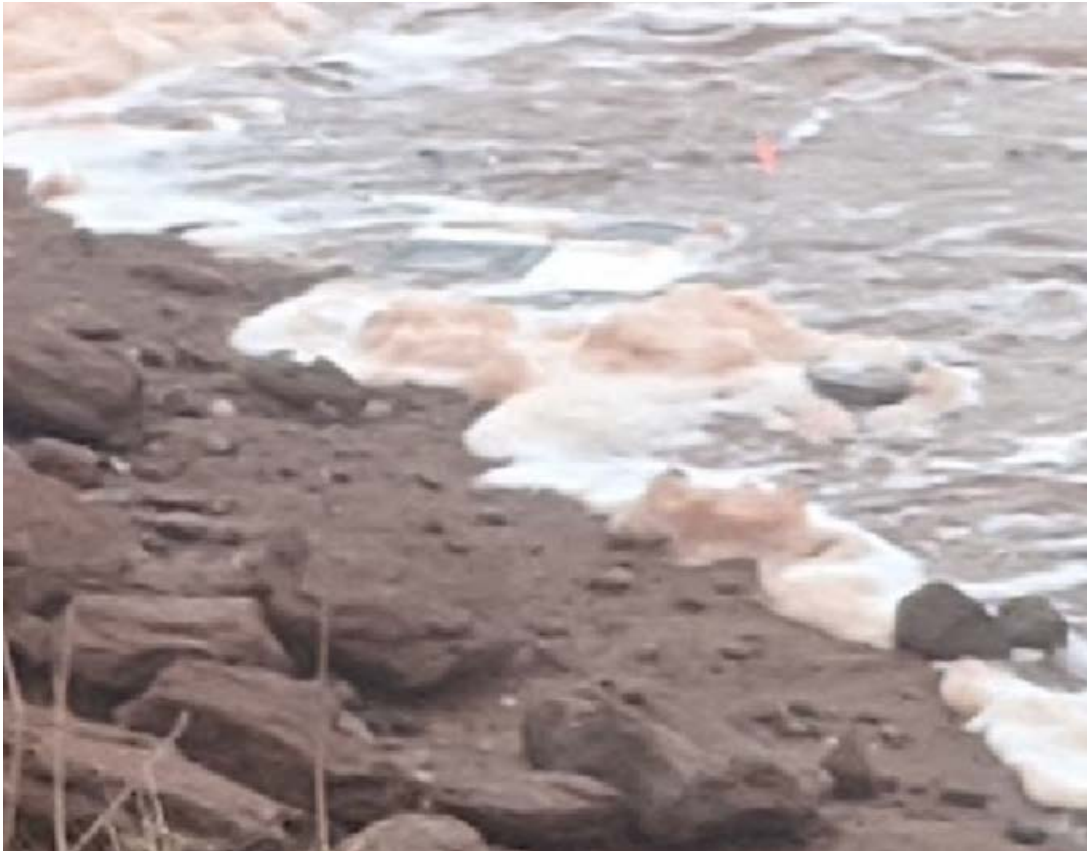
- **Miminegash** - In order to capture the new expanded area of Miminegash, setup and flight time takes approximately 5 hours. During this time, the tide can rise substantially, which means that by the time the southern end of the site is completed, beach area to lay GCPs and for the observer to stand is limited. During the November flight, a GCP almost washed away at the very end of the flight. Such a long flight and large area should not be required at this site, as the timing of the tides could provide less than ideal imagery.

Fig 43. GCP starting to float away at Miminegash as tide comes in at end of survey

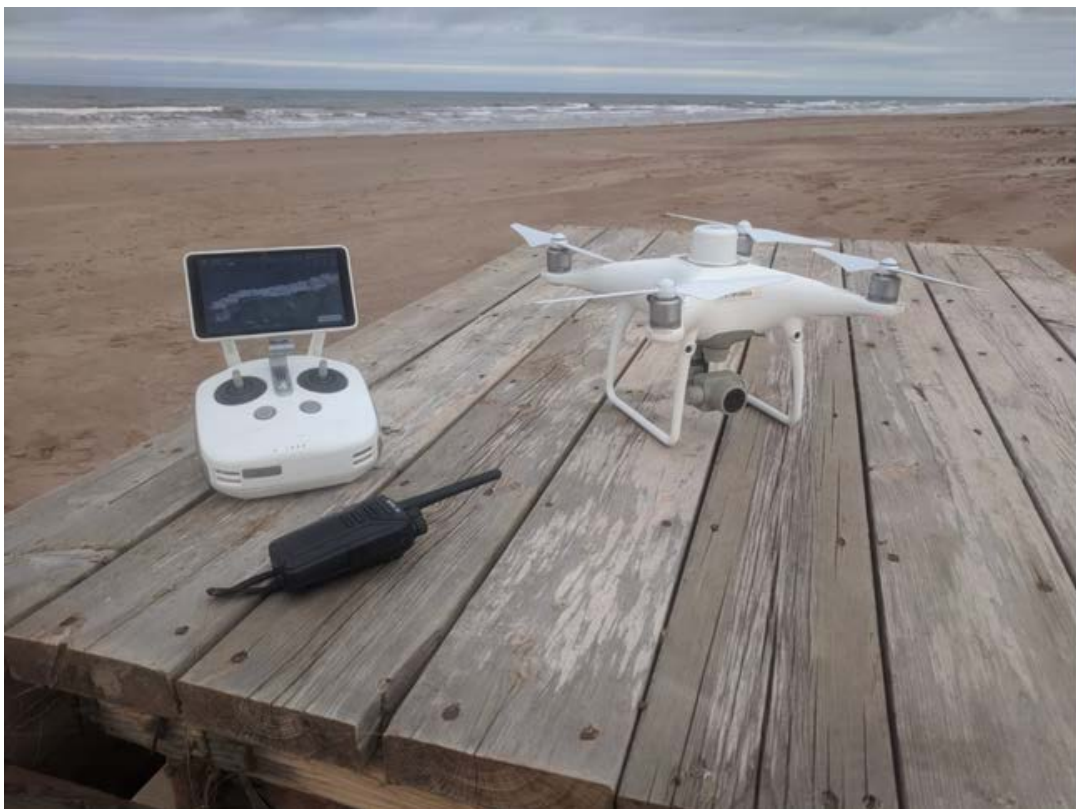
Fig 45. RPAS setup at Crowbush
