**COMMUNITY OF VICTORIA,  
PRINCE EDWARD ISLAND  
SEAWALL REPLACEMENT PROJECT**

HABITAT ASSESSMENT & GEOTECHNICAL INVESTIGATION

20 September 2017

Project No: 17-12374

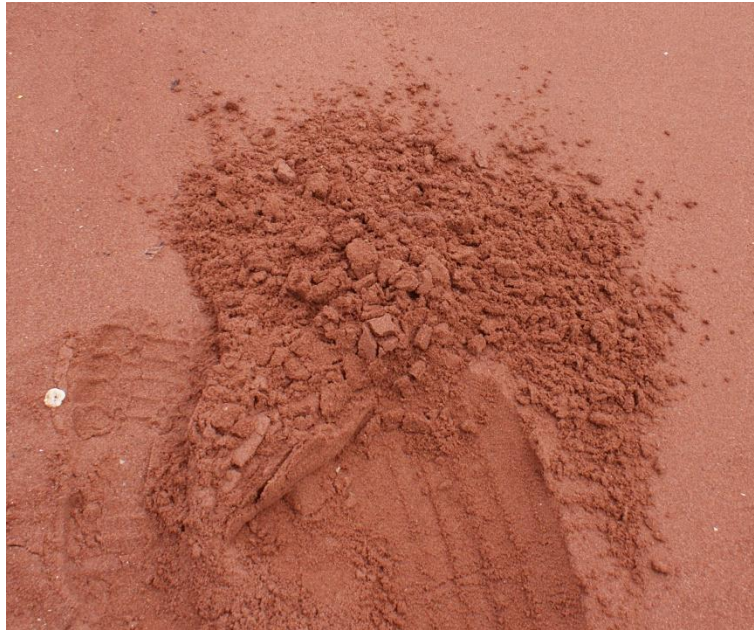
In both the Key Study Area (Figure 3) and the general area (Figure 4) course sand was the most predominant habitat type. The sand was visually uniform in size, consistent in colour across the site, and was firm and dry in the intertidal zone (Figure 5).

Figure 5. A representation of the course sand habitat observed at the Community of Victoria waterfront in April 2017.

Generally uniform sand beaches are not productive habitats, and this was the case for the three separate course sand areas within the study area.

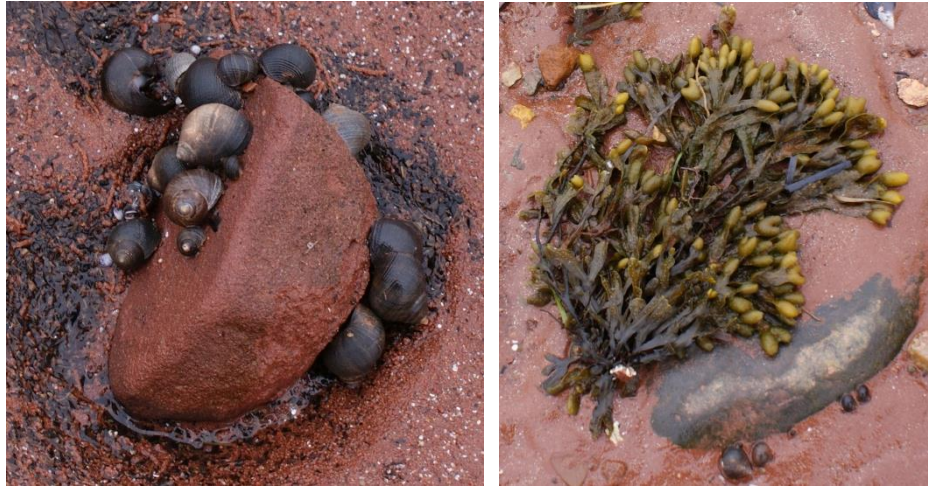
The only live flora and fauna observed were clustered around rocks, which were predominantly found higher in the intertidal. Common periwinkles (*Littorina littorea*), which are a very common species in Atlantic Canada found in a wide variety of habitats, were observed on or around rocks (Figure 6). Spiral wrack (*Fucus spiralis*), a very common marine algae species in Atlantic Canada was found with their holdfasts attached to rocks and other hard surfaces (*i.e.*, wood, etc) (Figure 6).

Figure 6. Live species observed within the course sand habitat observed at the Community of Victoria waterfront in April 2017: Common periwinkles (*Littorina littorea*) [on left], spiral wrack (*Fucus spiralis*) [on right].

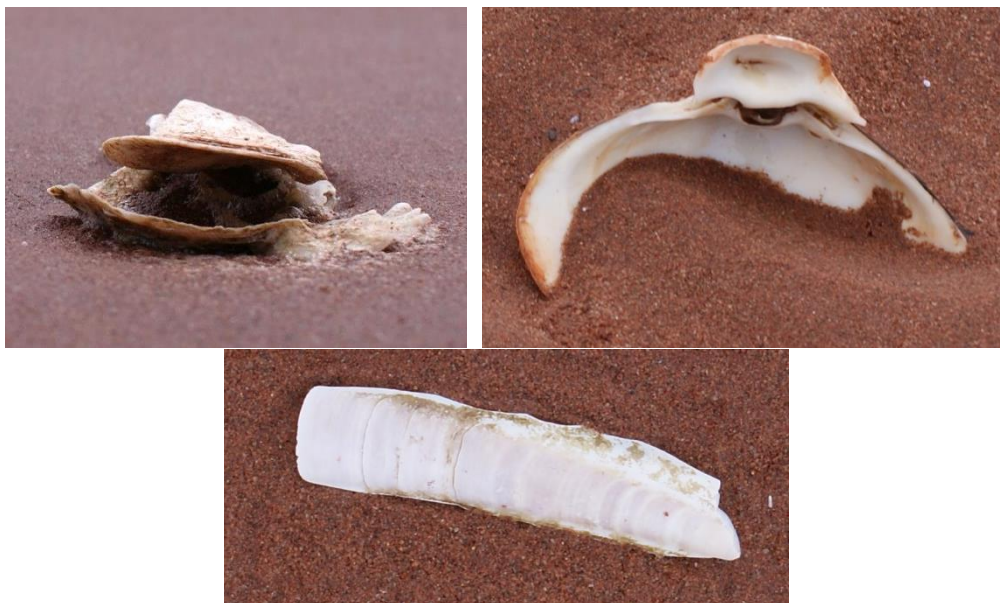
In addition to the live species observed, indications that other species lived in the region were observed. This included common oyster (*Crassostrea virginica*), hard clam (*Mercenaria mercenaria*) and razor clam (*Ensis directus*) shells (Figure 7); no live bivalves or any siphon holes were observed within any of the three course sand areas surveyed. As well spiral wrack (*Fucus spiralis*) and eelgrass (*Zostera marina*) were observed washed up on the beach (Figure 8); no live eelgrass was observed in the course sand habitat.

Figure 7. Bivalve shells observed within the course sand habitat observed at the Community of Victoria waterfront in April 2017: common oyster (*Crassostrea virginica*) [top left], hard clam (*Mercenaria mercenaria*) [top right] and razor clam (*Ensis directus*) [bottom].

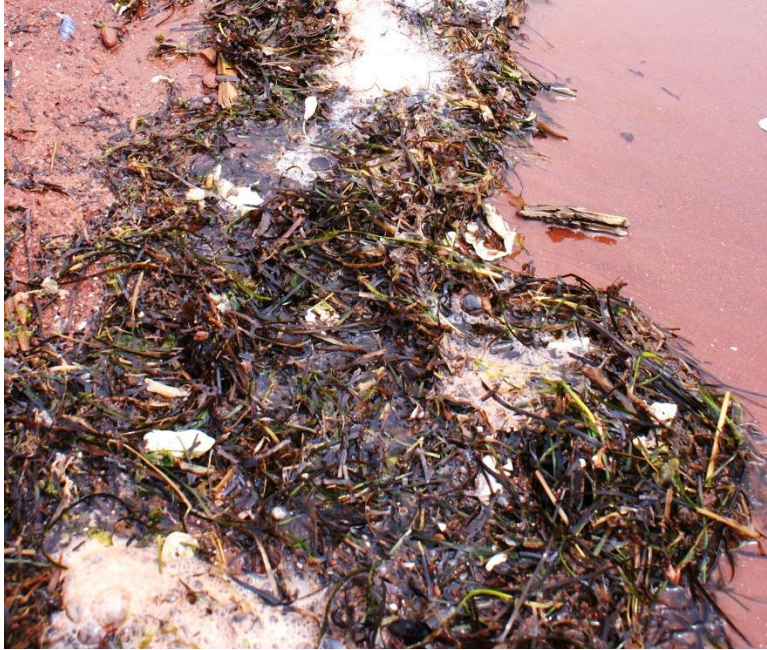
Figure 8. Washed up eelgrass (*Zostera marina*) observed within the course sand habitat observed at the Community of Victoria waterfront in April 2017.

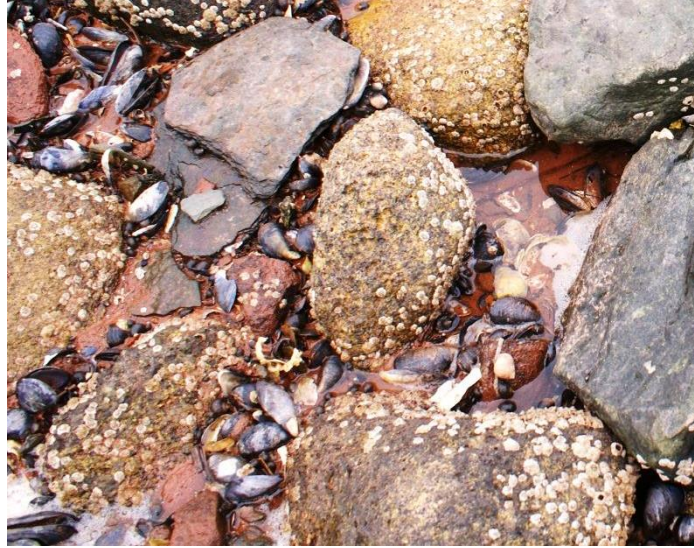
The cobble and wood habitat supported a variety of species (Figure 11 & Figure 12), including the northern rock barnacle (*Balanus balanoides*) which is a common and abundant species in Atlantic Canada, common periwinkles (*Littorina littorea*), and blue mussels (*Mytilus edulis*) which is a common species in Atlantic Canada. As well, a single common oyster (*Crassostrea virginica*) was observed.

Figure 12. A view of the species located within the cobble and wood habitat, including the northern rock barnacle (*Balanus balanoides*), common periwinkles (*Littorina littorea*), and blue mussels (*Mytilus edulis*).

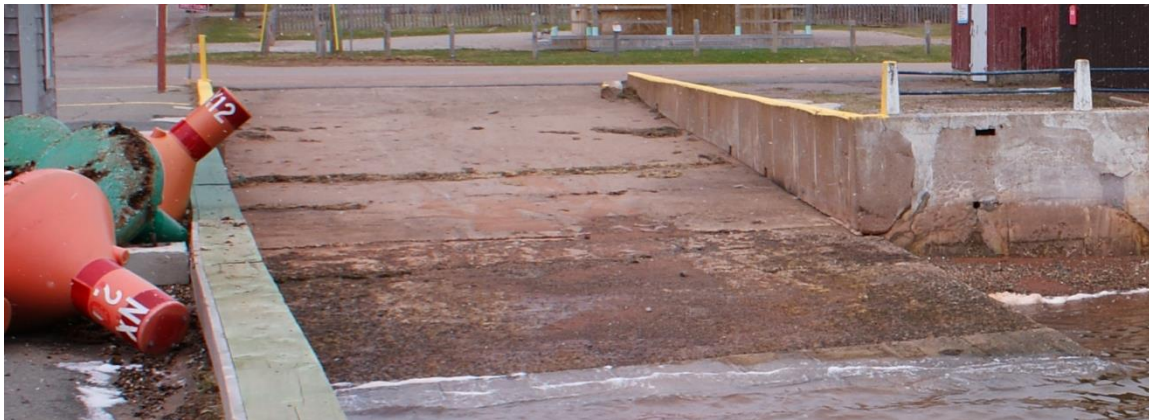
The concrete launch ramp is located directly adjacent to the wharf (Figure 13). This habitat supported a large population of common periwinkles (*Littorina littorea*), which were observed in any cracks in the concrete (Figure 14). As well common periwinkles (*Littorina littorea*), blue mussels (*Mytilus edulis*) and common oysters (*Crassostrea virginica*) were observed on the steel retaining wall of the wharf (Figure 14).

Figure 13. View of the concrete launch ramp adjacent to the wharf on the Community of Victoria, PE waterfront.

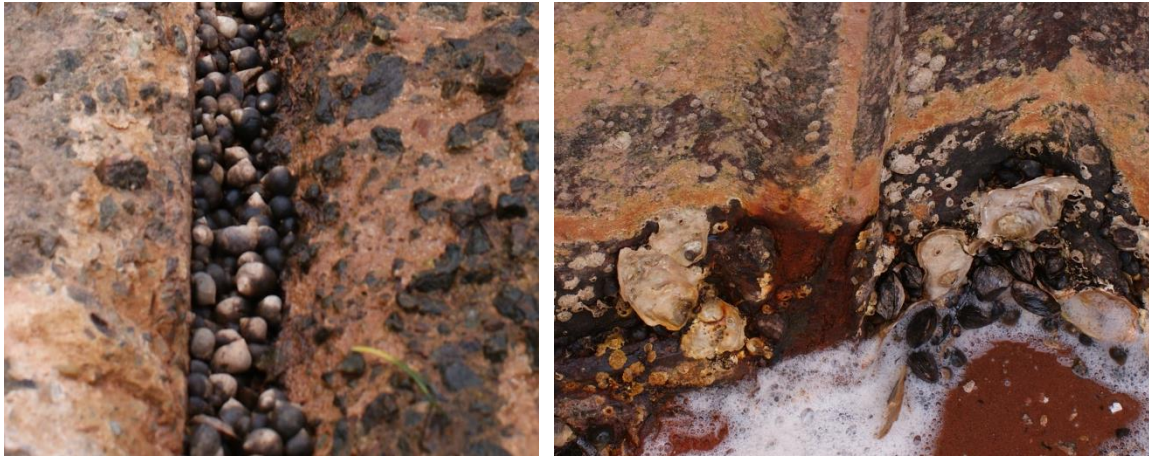
Figure 14. Species observed on the concrete launch ramp and the adjacent steel breakwater of the wharf on the Community of Victoria, PE waterfront. Common periwinkles (*Littorina littorea*), were observed in any cracks in the concrete [on left]. As well common periwinkles (*Littorina littorea*), blue mussels (*Mytilus edulis*) and common oysters (*Crassostrea virginica*) were observed at the base of the seawall [on right].

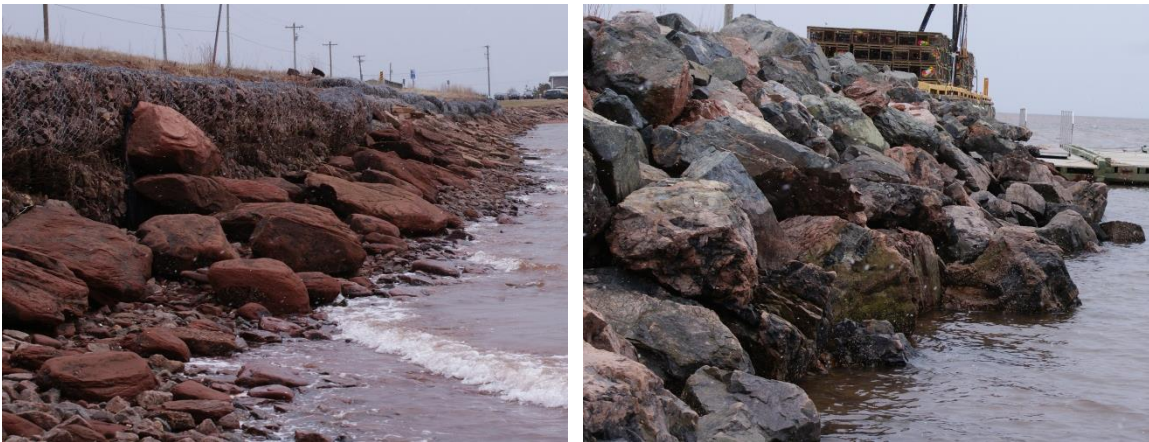
Within the larger study area (Figure 4) there were two sections of rubble mound breakwater that were observed (Figure 15), which is similar to the habitat that will be created if the proposed rubble mound seawall is constructed as planned (Figure 2).

Figure 15. Two sections of rubble mound breakwater observed on the Community of Victoria, PE waterfront. One section was a combination of cobbles and boulders, which was adjacent to hwy 116 [on left], the other was adjacent to the concrete launch ramp and the smaller wharf [on right].

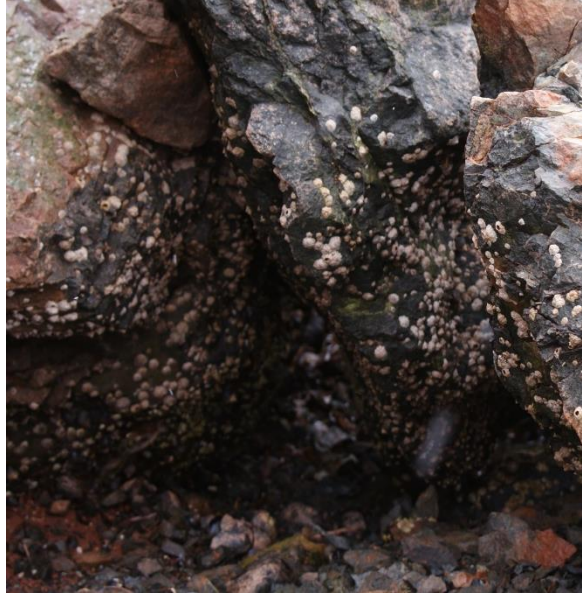
The rocks of the rubble mound breakwaters supported a variety of species, including the northern rock barnacle (*Balanus balanoides*), common periwinkles (*Littorina littorea*), blue mussels (*Mytilus edulis*) and common oysters (*Crassostrea virginica*) were observed on the rubble mound breakwaters (Figure 16).

Figure 16. A close up of a protected area between a couple of large boulders that make up the rubble mound breakwater on the Community of Victoria, PE waterfront. While the northern rock barnacle (*Balanus balanoides*) was most common, common periwinkles (*Littorina littorea*), blue mussels (*Mytilus edulis*) and common oysters (*Crassostrea virginica*) were also observed.

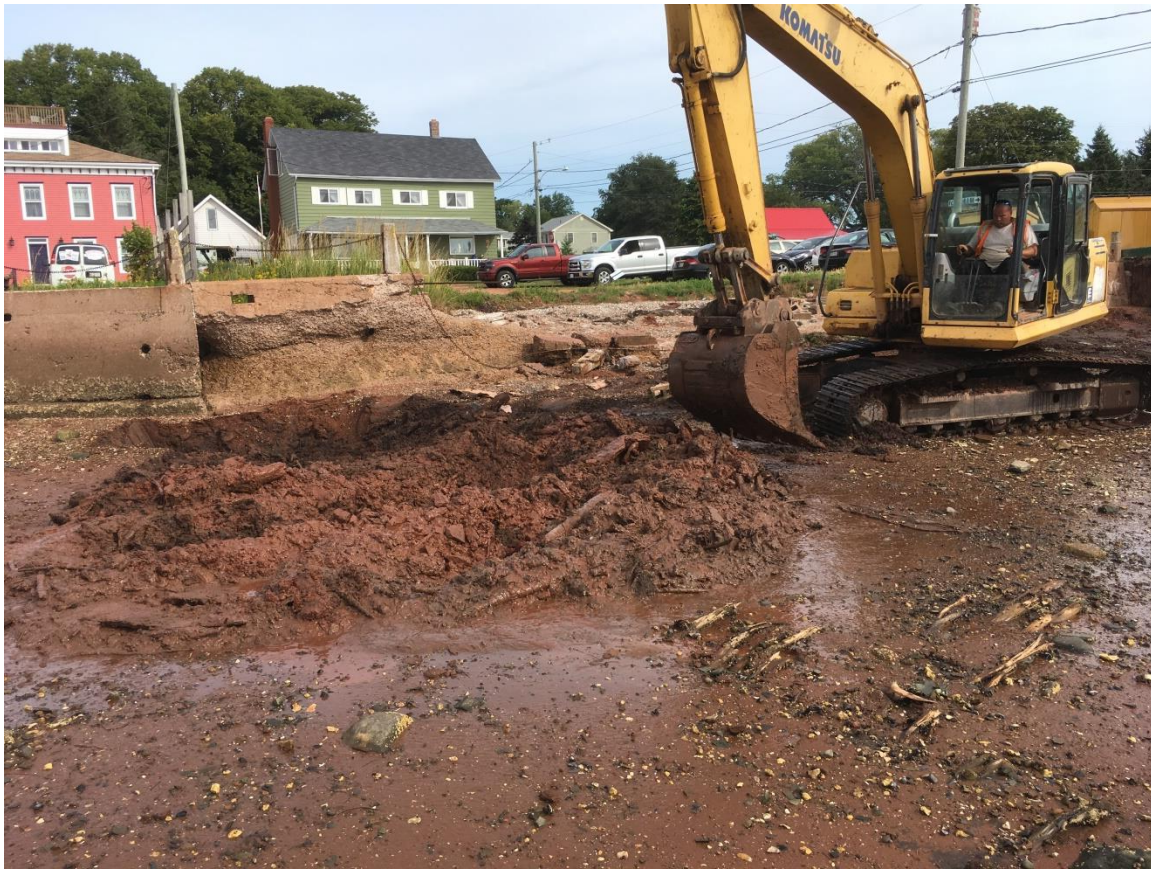
The objective of the geotechnical investigation was to assess the subsurface conditions of the intertidal zone adjacent to the current seawall (Figure 17); within the footprint of the proposed seawall project. Additionally, this geotechnical information will be used to make recommendations for the geotechnical component of the proposed seawall project.

Figure 17 – Digging a test pit at the Community of Victoria seawall project site, August 30, 2017.
