HAZARDOUS MATERIALS ASSESSMENT

Coast Guard Building

1 Queen Street,

ALL-TECH Project No.: PE22400

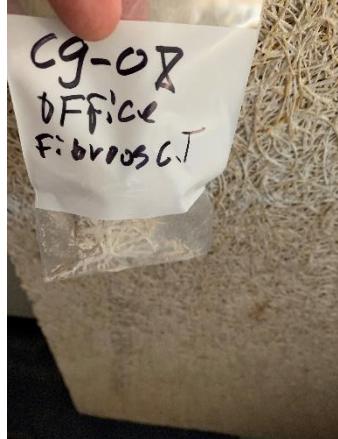
CG-19	Tan/Gray textured covering with White caulking & yellow mastic	Workshop	None Detected in covering, caulking or mastic	
-------	--	----------	---	--

CG-08	Acoustic fibreboard	Office area	None Detected
