HAZARDOUS MATERIALS ASSESSMENT

Royalty Centre
40 Enman Crescent,
Charlottetown, PE

June 28, 2023

ALL-TECH Project No.: PE22400

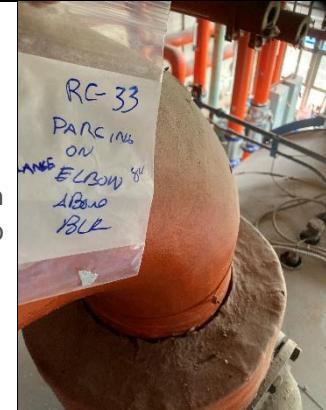
<p>ACM parging cement is present on pipe fittings in boiler room. Sample RC-33 above boiler found to contain 60% Chrysotile Asbestos.</p>

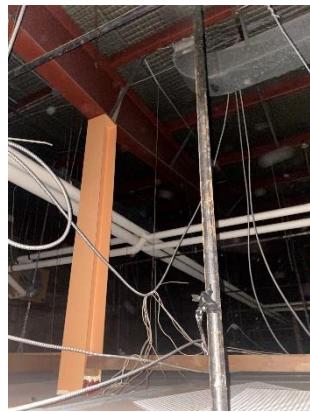
Duct insulation was covered with fiberglass insulation or non-insulated. No suspect asbestos coverings were noted or reported.

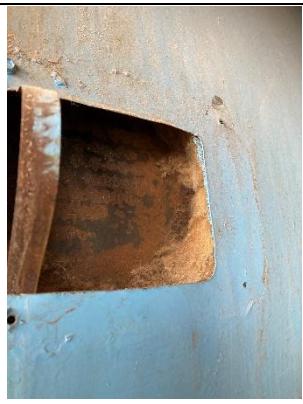
Photo 4

Boiler insulation visibly identified as fiberglass insulation (photo 4).

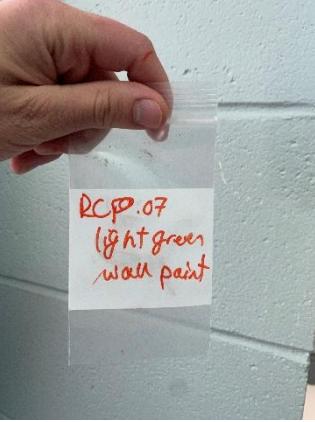
RCP-08	Green paint / Door trim surface	1 st Level	0.076

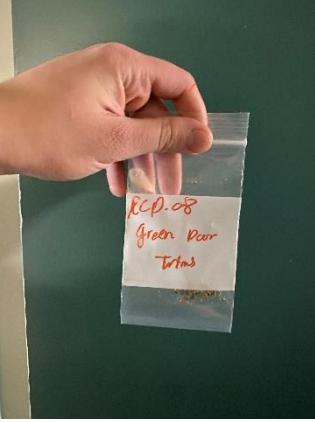
RCP-09	Grey paint / Floor surface	1 st Level record storage	0.13

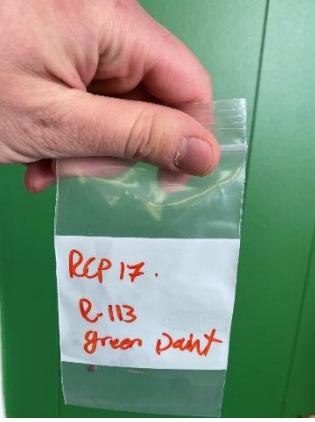
RCP-18	Grey paint / Wall surface	1 st Level ping pong room	< 0.0079

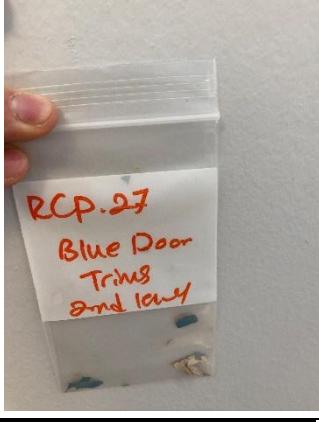
RCP-28	Cream color paint/ Wall surface	2 nd level outside room 273	void	
RCP-29	Brown paint / Door trim	Room 201	0.073

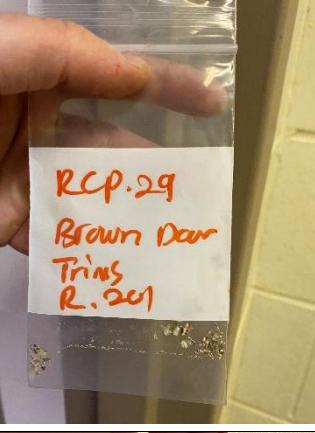
RCP-30	Yellow paint / Wall surface	Room 251	0.028

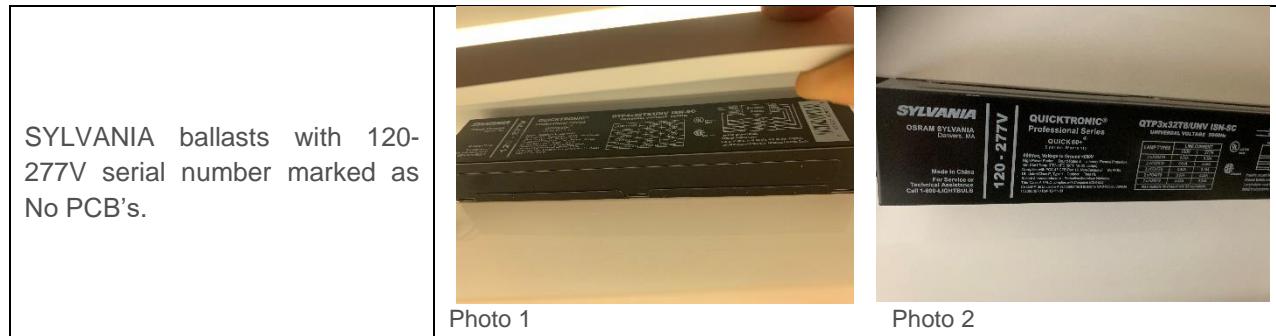
4.3.1 *Lighting Lamp Ballasts*

Through referencing and markings on lamp ballasts, it was determined that the ballasts observed on site are non-PCB containing and some others are PCB containing.

Some older model light fixtures and lamp ballasts were observed within the building. A variety of newer and older ballasts were observed and documented below in this section.

Some ballasts have been replaced with various updated non-PCB containing ballasts as noted in tables below. These ballasts are labelled as No PCB's on manufacturers labels.

If lamp ballasts with different serial numbers than those identified above are encountered during removal, it should be determined whether they are PCB-containing and disposed of accordingly. Unidentified ballasts with presence of leaking oils should be treated as PCB containing ballasts. The following is the assessed records for inspected ballasts within various random locations throughout the building.

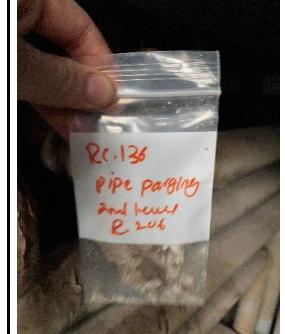
RC-137	Pipe parging			F	C	Fair	5	
206B	Sun Room above Cancer Society	VRC-136	Pipe parging	Chrysotile 60%	7 units	F	C	Fair	5	
		VRC-151	Transite hardboard panel	Chrysotile 20%	11 m2	NF	A	Good	5	
211H	Corridor between Sport PEI and Construction Assoc.	VRC-136	Pipe parging	Chrysotile 60%	23 units	F	C	Fair	5	
213	Alternative Ed	VRC-151	Transite hardboard panel	Chrysotile 20%	8.7 m2	NF	A	Good	5

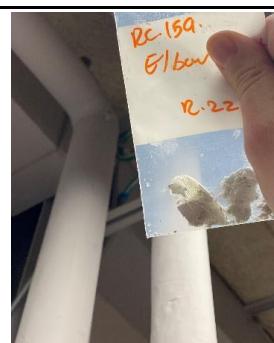
VRC-152	Transite hardboard panel	Chrysotile 20%	8.7 m2	NF	A	Good	5	
		RC-152	Transite hardboard panel	Chrysotile 20%	5.6 m2	NF	A	Good	5	
		VRC-158	Pipe parging	Chrysotile 65%	6 units	F	C	Fair	5	
230H	Main Hallway Between Janitor Closet and Construction Assoc.	VRC-158	Parging on hangers	Chrysotile 65%	2 units	F	C	Fair	5
